Analysis of CTFII structures.

Iris of W and Mo.

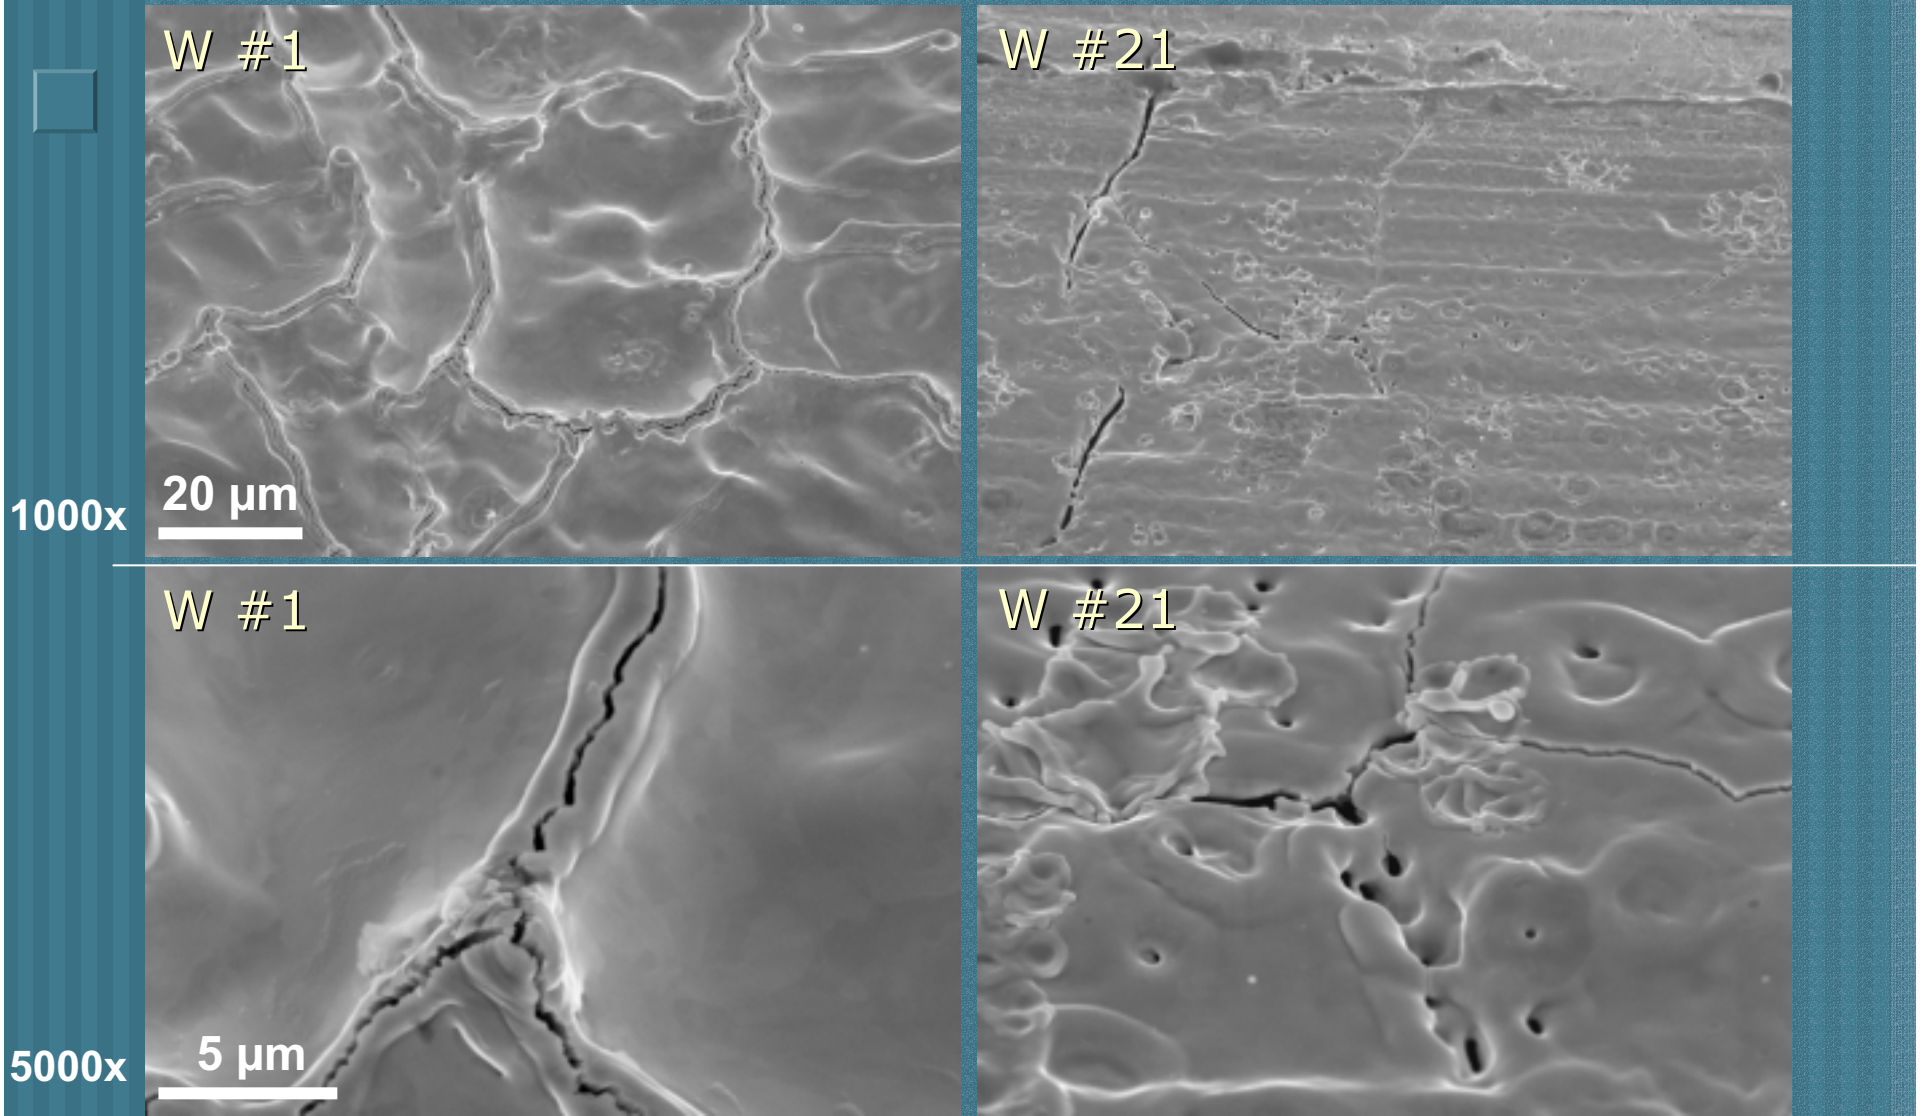
Surface modification in tip region. W structure, comparative 1st/mid-position.

- Melting crests + network of micro cracks.
- W:
 - Crack network of $\sim 50 \mu\text{m}$
 - Does it corresponds to Prior Particle Boundaries? No, in principle W powder is $2\div 6 \mu\text{m}$.

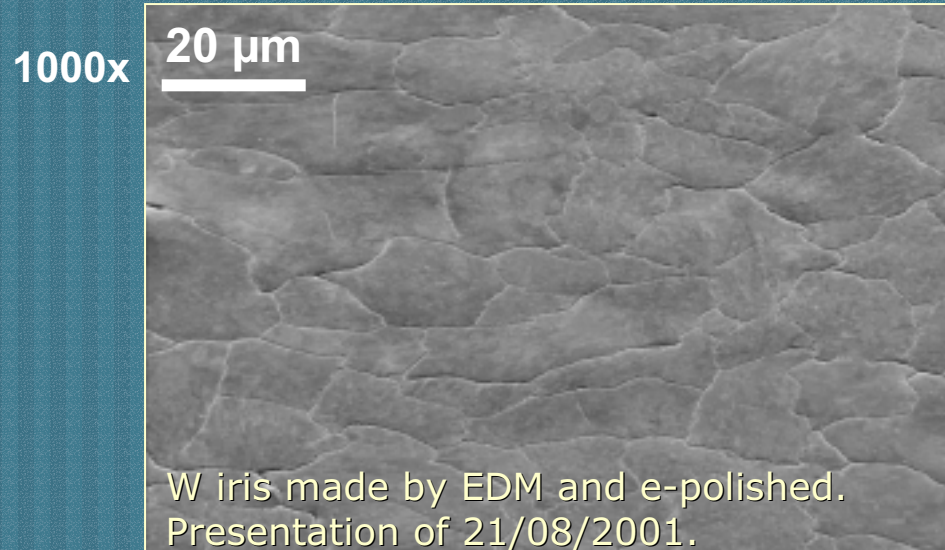
- Comparative with previous experience on thermal cracks in W rod pieces.

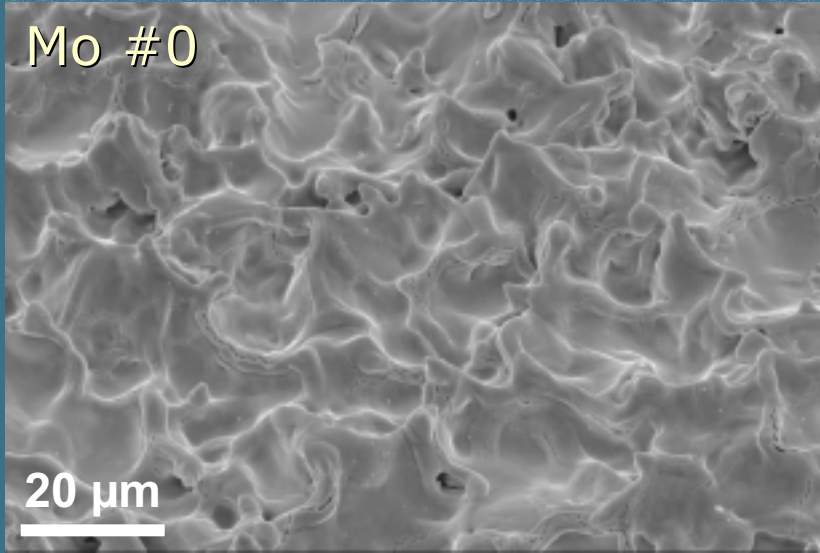
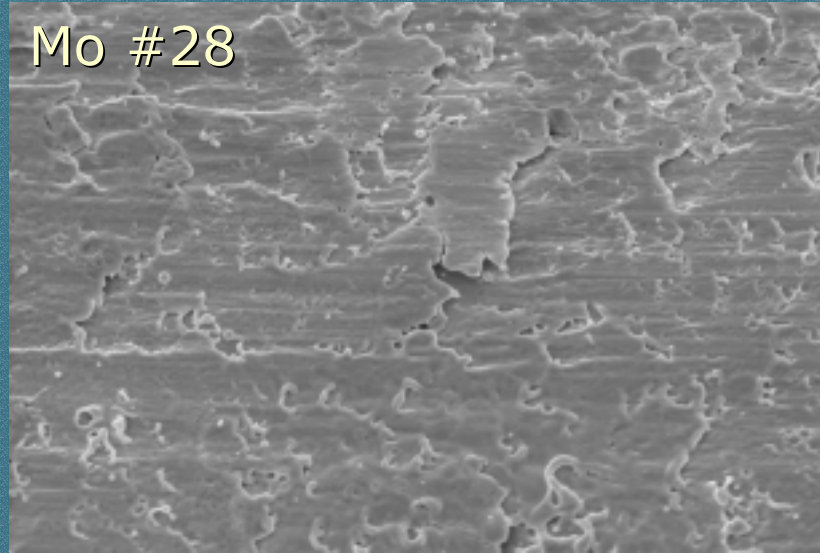
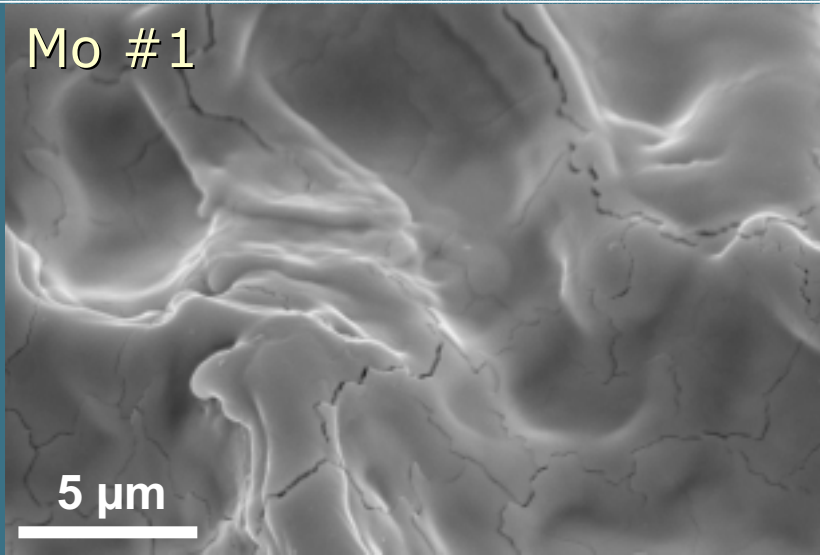
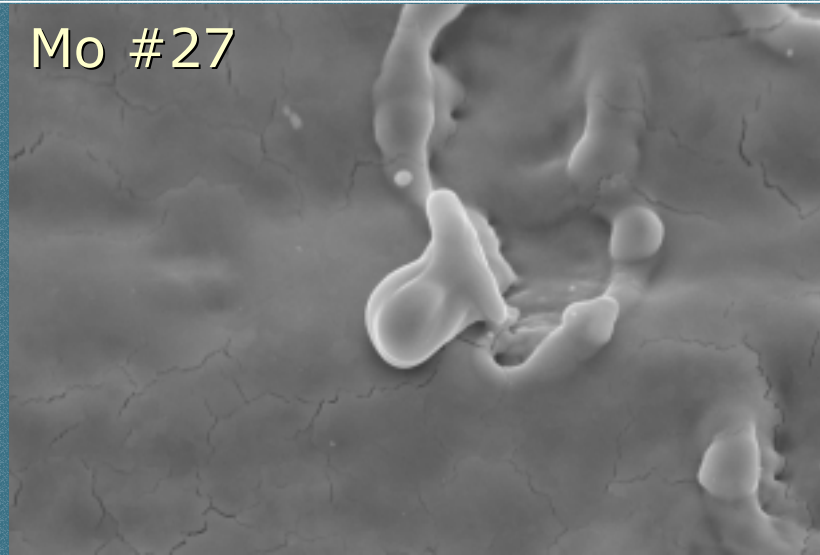
Surface modification in tip region. Mo structure, comparative 1st/mid-position.

- Is heating more intense around cracks?.
- Mo:
 - Chaotic melting crests.
 - Cracks less opened than in W and form a finer mesh network, $\sim 3\mu\text{m}$ (same size as grains observed in fractured iris).

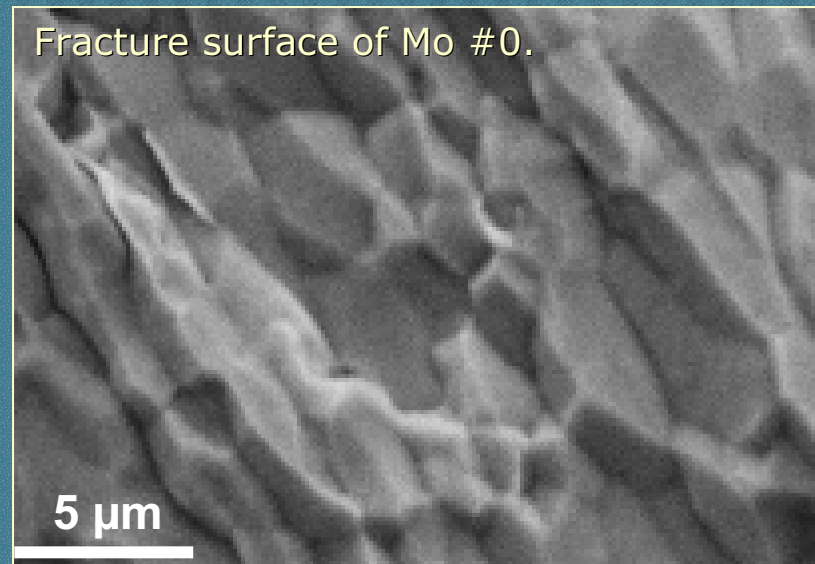
- Grain size of Mo irises from fractography.

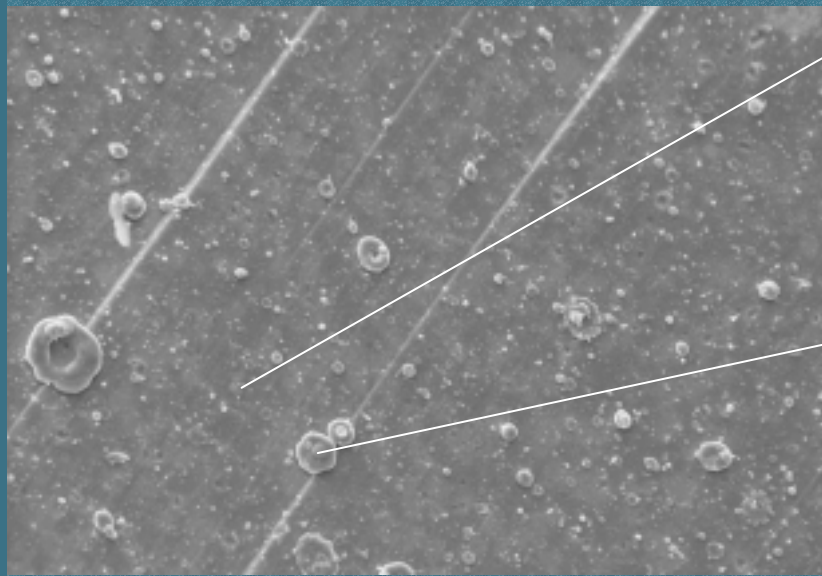
Wall (Cu disc) of 1st cavity
from Mo structure.

- Indications of metal loss in 1st irises:
 - Metal projections towards Cu discs.
 - Mo evaporation (Blackening of iris and Cu disc, due to deposit of MoO₃).
 - Reduction of cross-section of 1st Mo iris.

At%
73 Cu
20 O
5 Mo
3 Si

At %
54 Mo
38 O
9 Cu

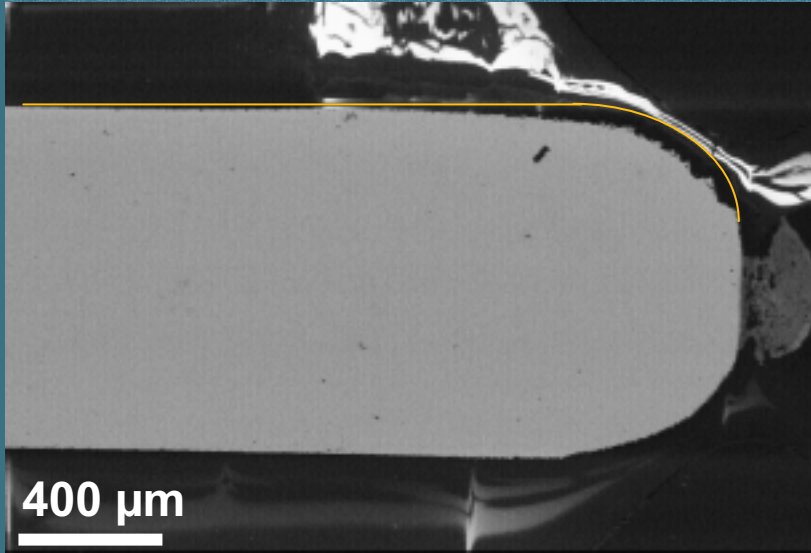
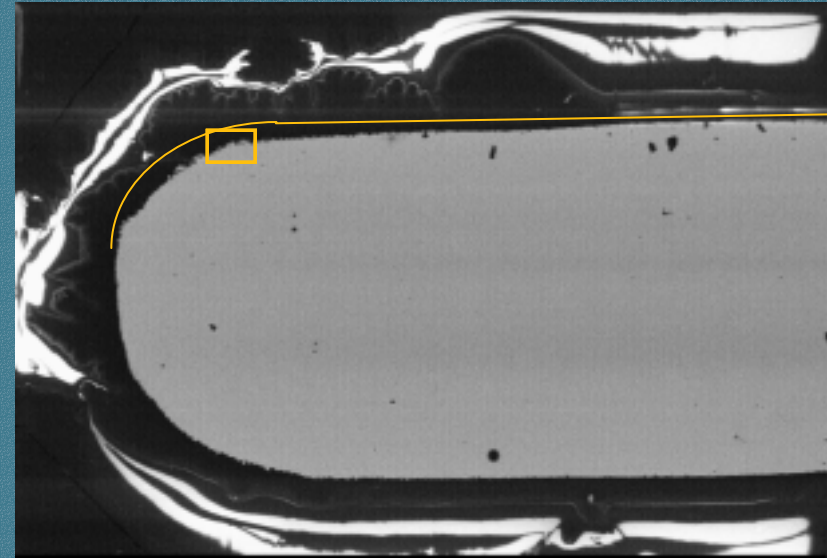
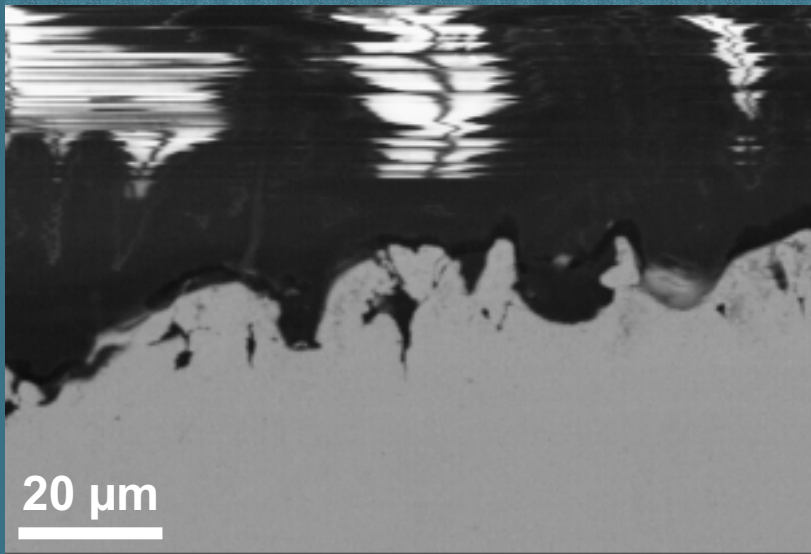
Surface modification in tip region. Cross-section of Mo #0.

- Slight loss of material or previous geometrical defect.
- Protrusions are 15 μm high.
- Cracks are superficial.

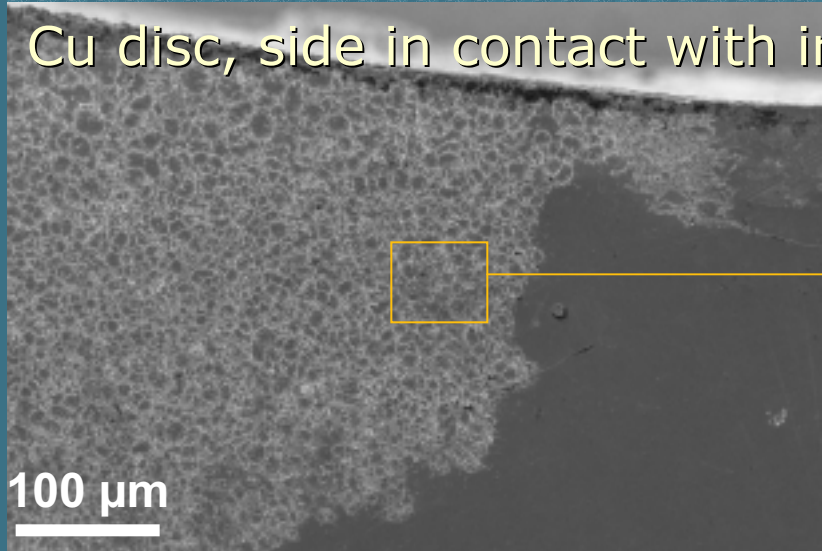
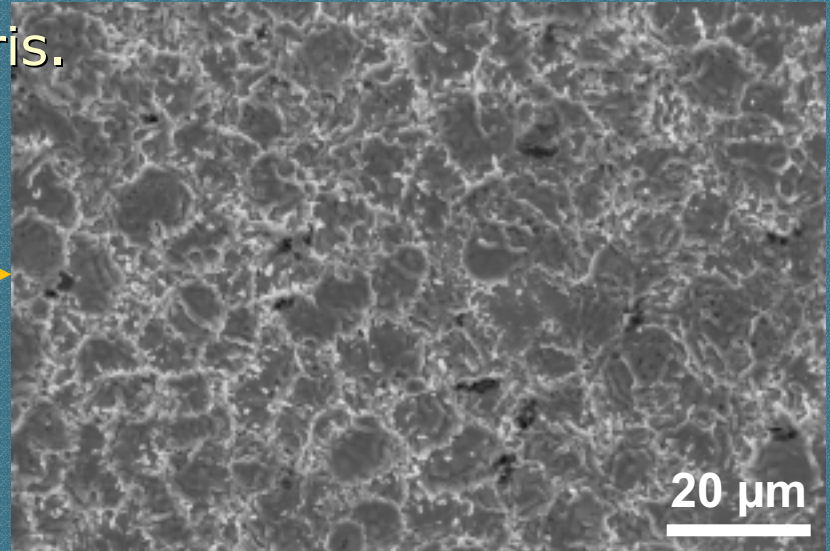
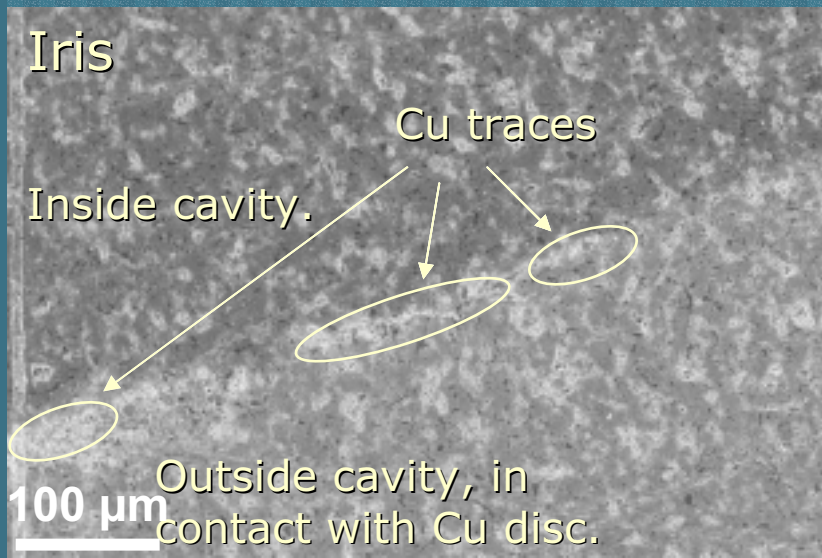
Cu disc, side in contact with iris.

- Extensive copper splashes in particular disc to iris contact regions (In W structure, clamped less tightly)
- Also systematic presence of Cu traces along the cavity boundary line (in both, W and Mo structures)

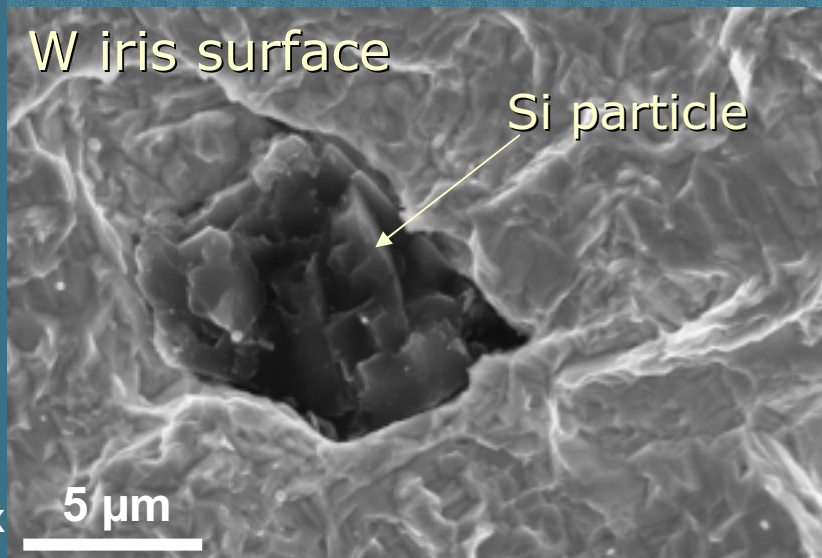
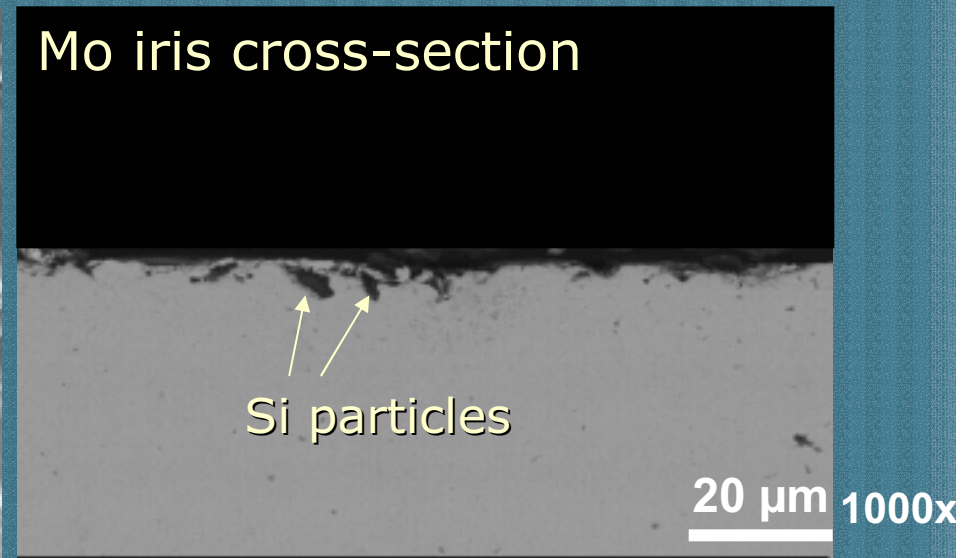
1. Si particles inlaid in ground (flat) surfaces of irises:
 - In both, W and Mo.
 - Regular distribution and size, $\sim 10 \mu\text{m}$.
 - It is not SiC, not SiO₂.

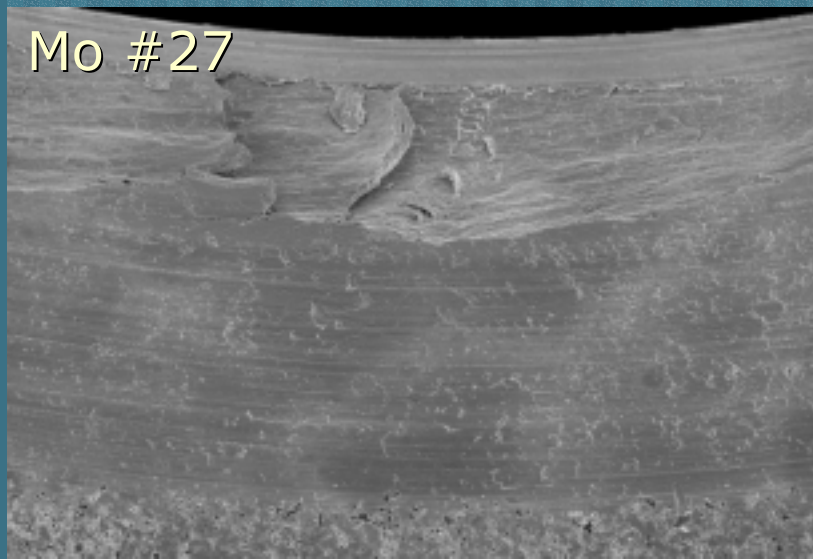
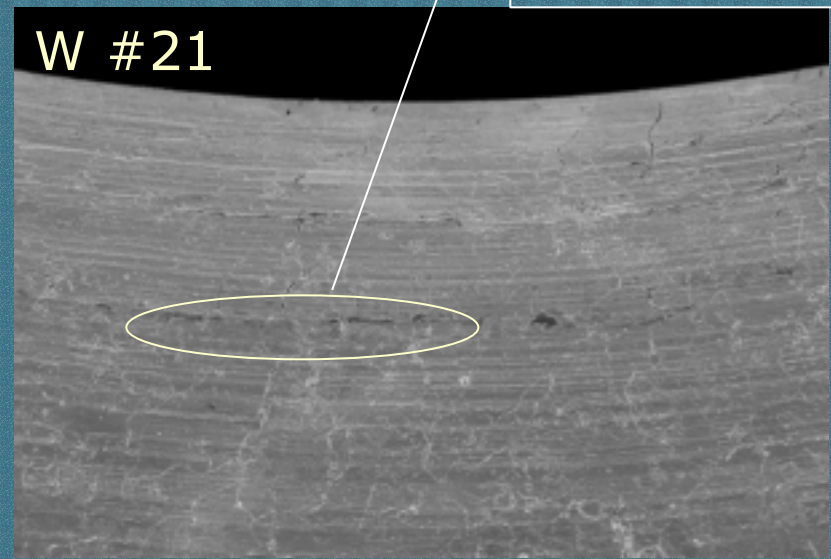
2. Poor machining finish in one Mo iris.
3. Steel traces in one W iris.

Fe	Cr
Ni	Mo
Mn
