# SEM analysis of structures with Mo iris run at CTF3 .

# Introduction.

- Background:
  - Iris-in-copper-disc structures.
  - Mo iris, fired at 800 °C.
  - Run in CTF3 2005, 30 GHz.
  - Run history presented by Roberto, see next slide.
- Analyses:
  - Surface SEM + EDS for first and last cavities.
- Compared to other structures run in CTFII and SLAC.

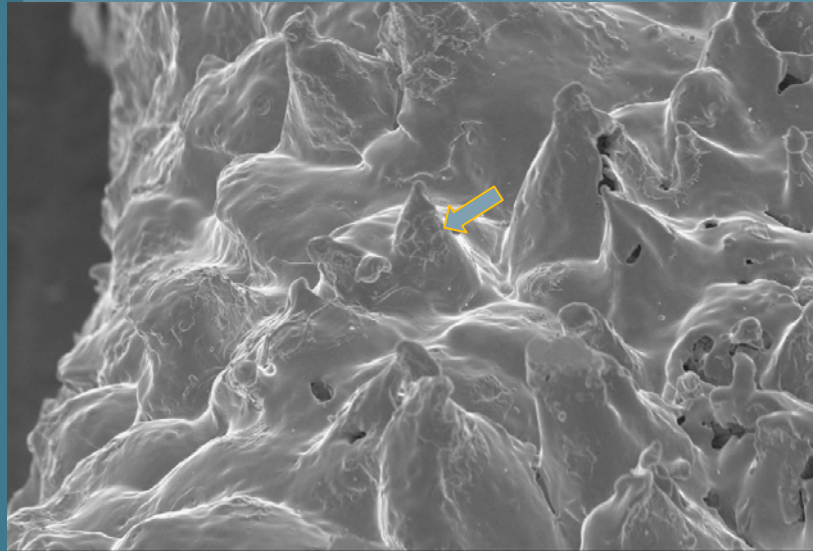
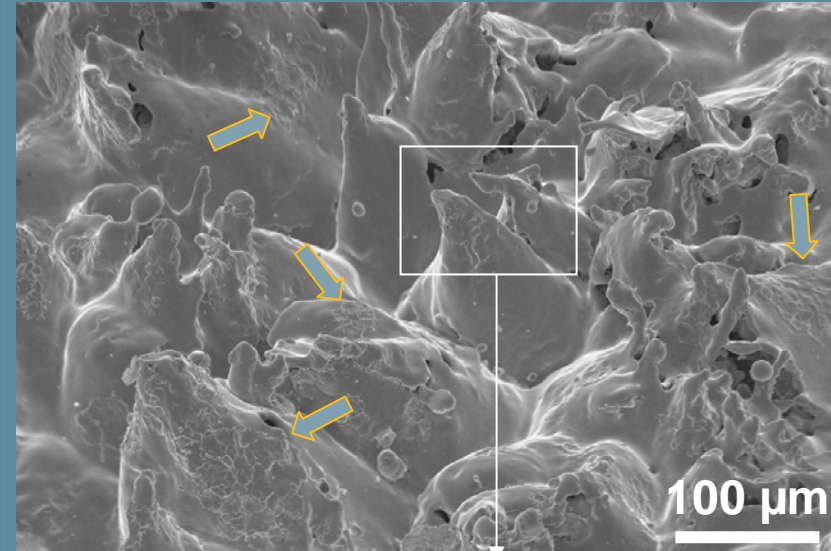
200x

Very **sharp** and **high** peaks.  
Different that what has been  
observed so far in DC spark  
craters.

Clusters of craters are not always  
localized on top of the peaks.

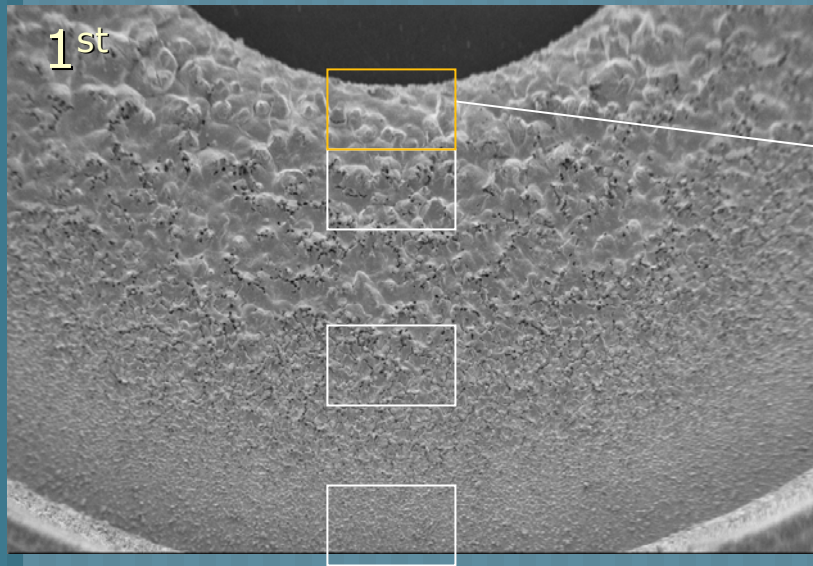
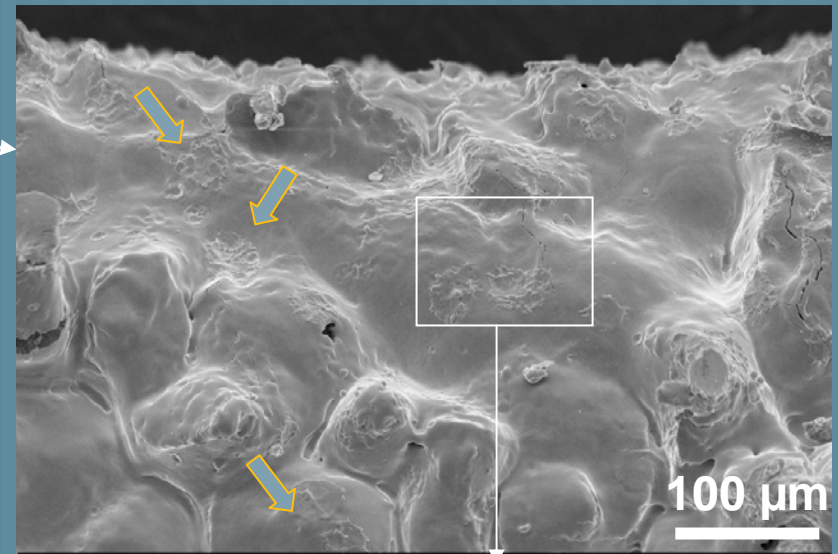
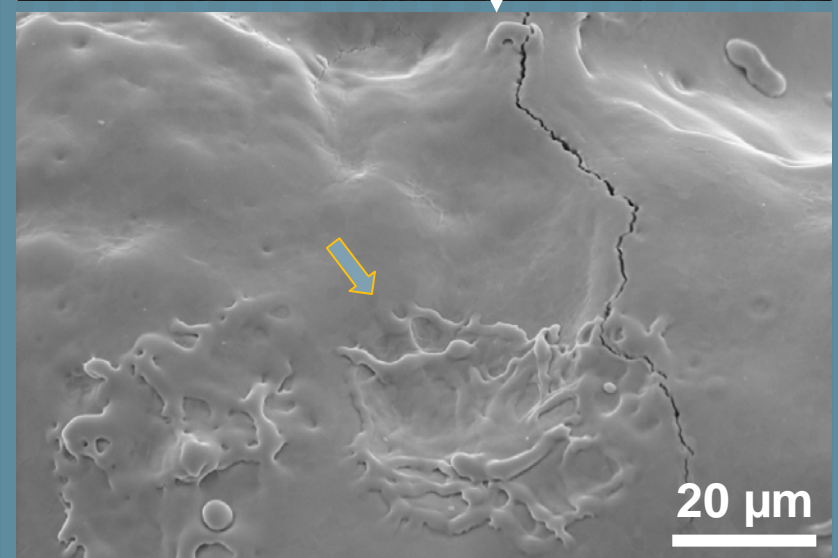
Localized clusters of craters.

Craters coexist with smoothly eroded surface.  
Two different phenomena?

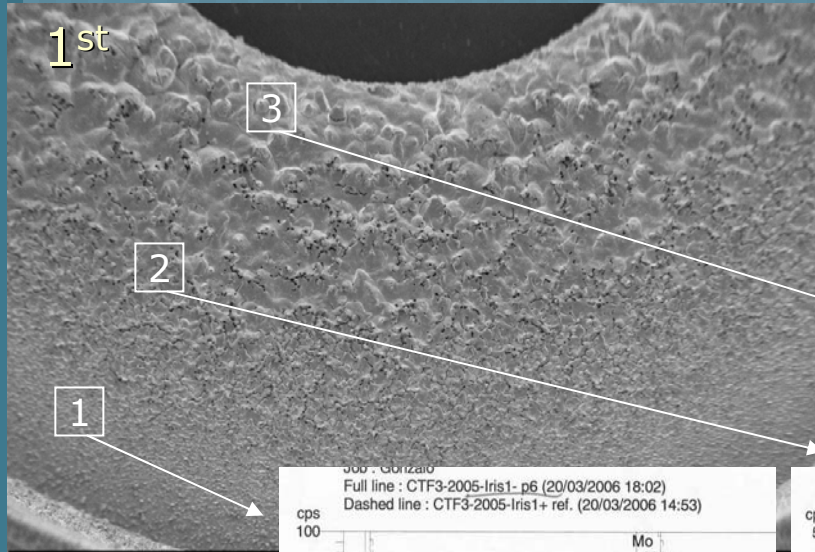
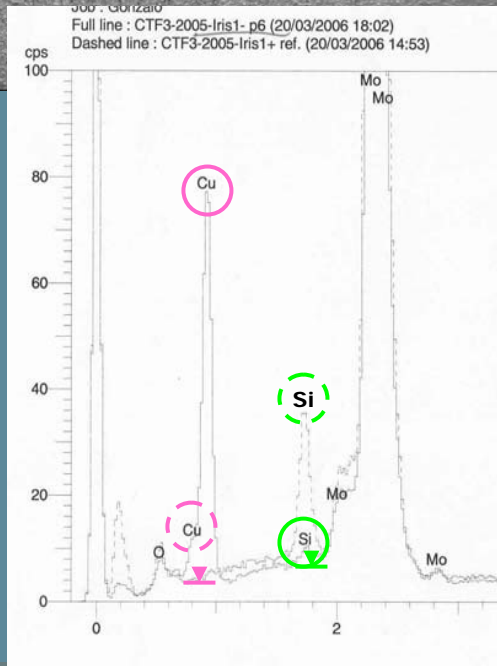
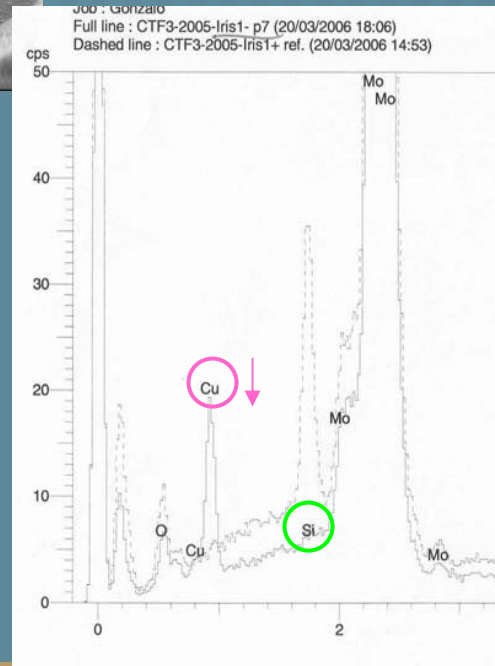
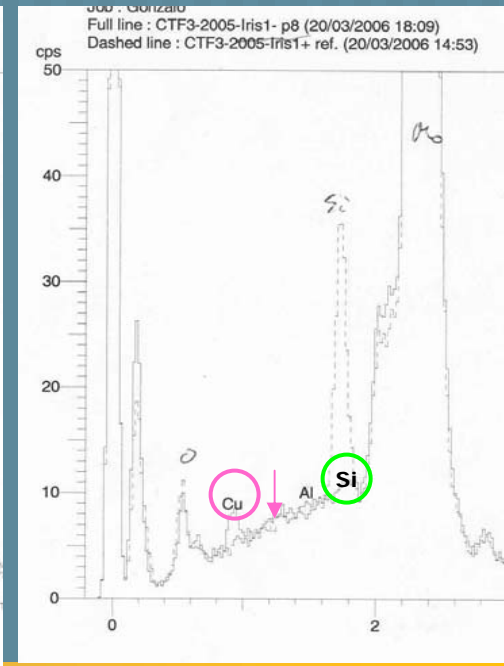
Ref.: Si peak from SiC embedded particles, no Cu peak

- 1: reduced Si, significant presence of Cu
- 2: absence of Si, presence of Cu
- 3: absence of Si, slight presence of Cu

- Copper contamination. The closer to the wall the higher.
- Si (from SiC particles) disappeared.

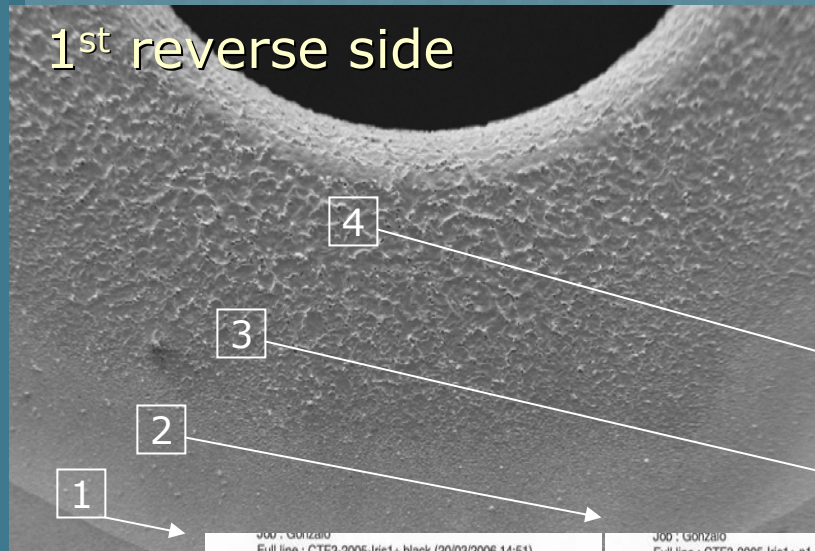
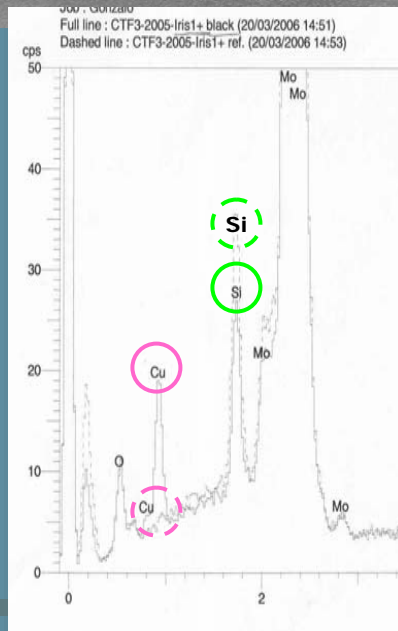
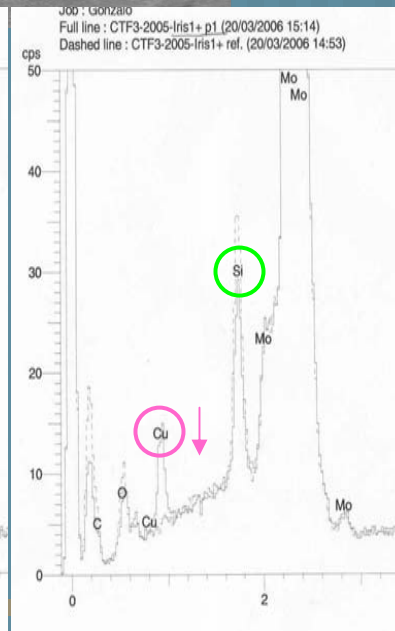
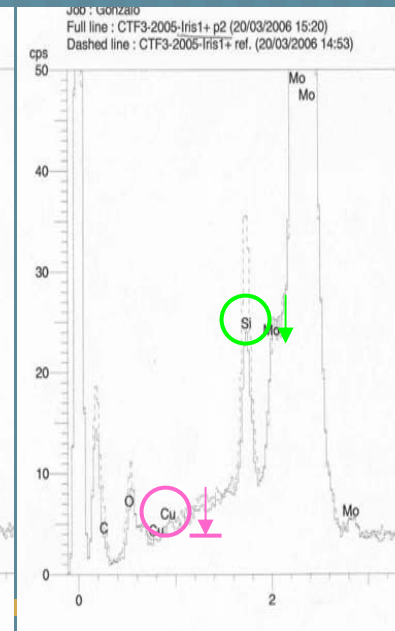
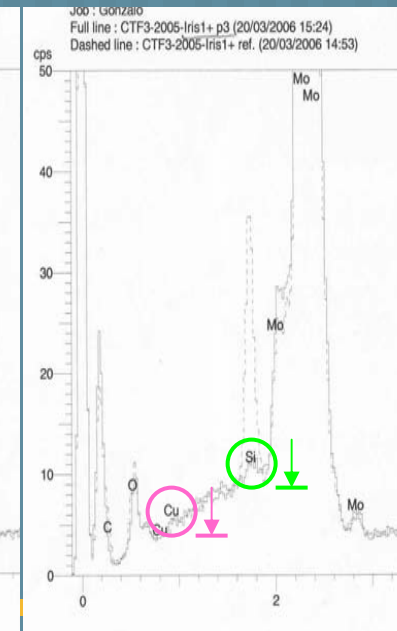
- Copper contamination. The closer to the wall the higher.
- Si (from SiC particles) starts disappearing.

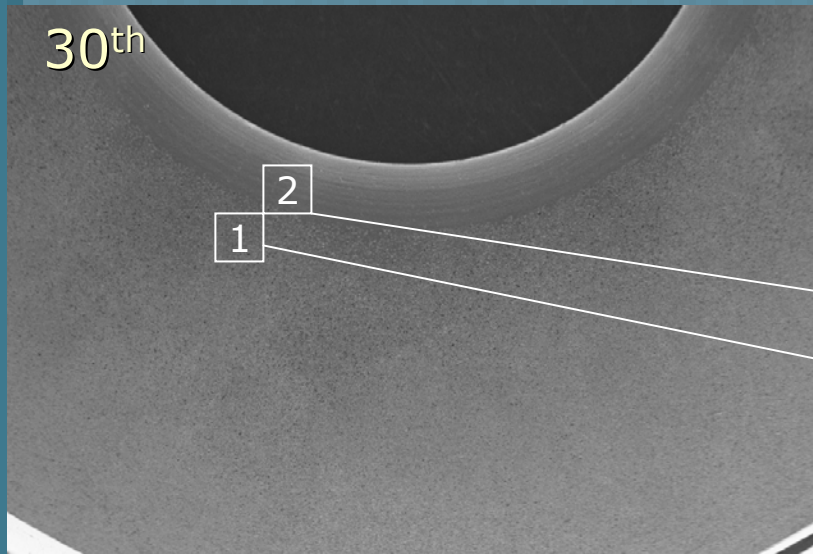
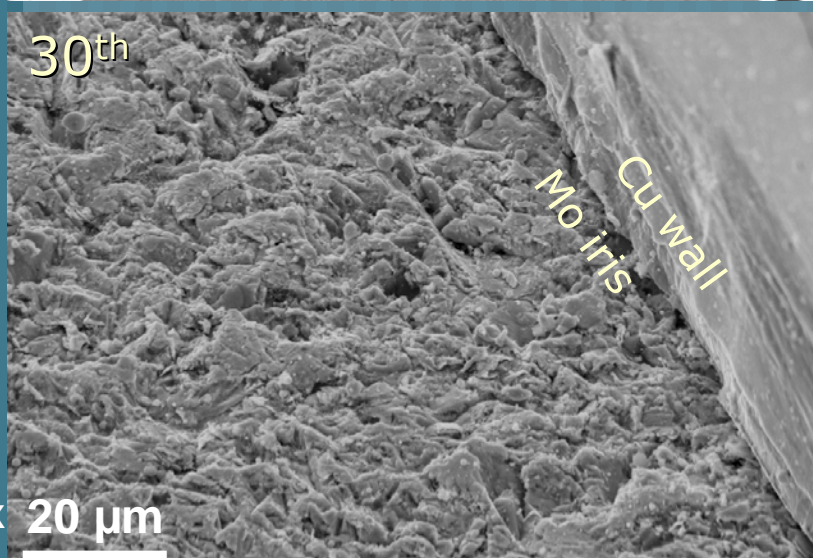
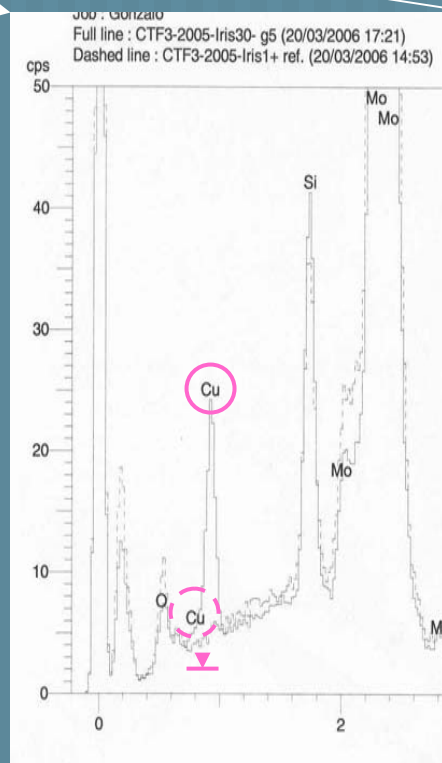
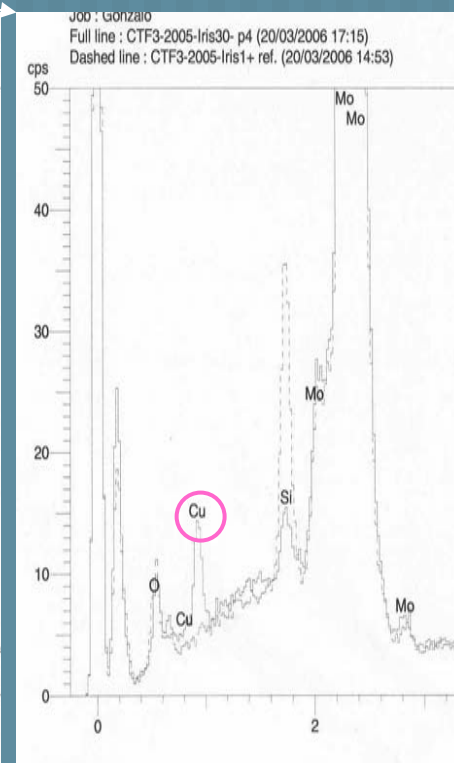
- Copper contamination also on the 30<sup>th</sup> iris!
- Though here the Cu wall do not seems remelt.

Does Cu contamination comes from most damaged first irises?
