# SEM analysis of HDS accelerating structures from recent 30 GHz tests at CTF3.

- Old for memory and remarks.
- HDS60 Cu
- HDS60 Cu small
- HDS11 Mo
- HDS11 Ti
- Cross comparisons and comments

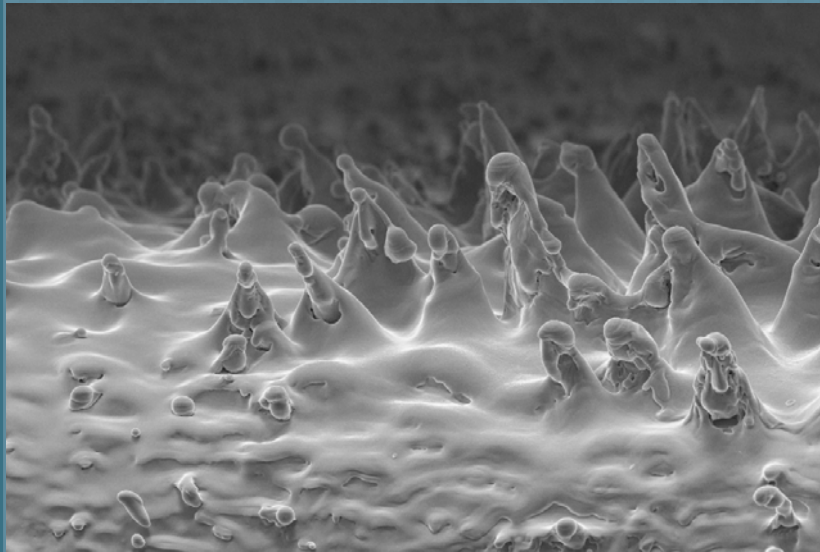
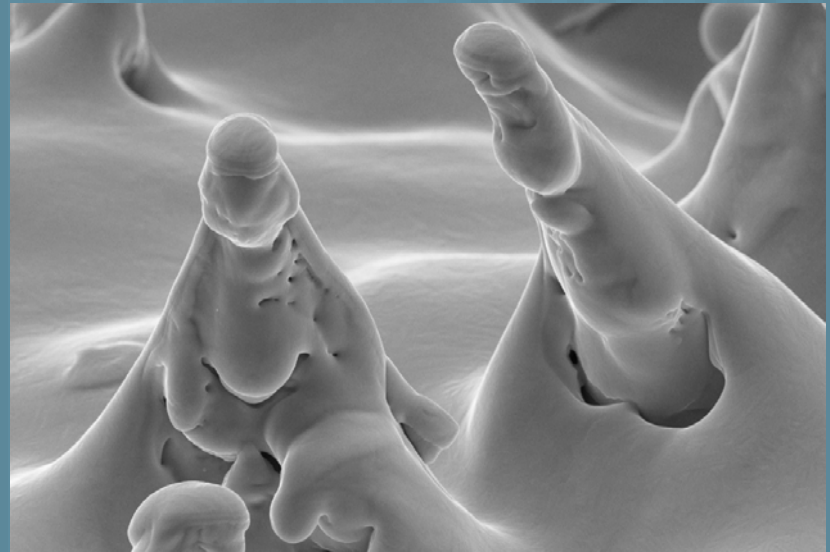
Cones seem to grow by repeated pulling of liquid.

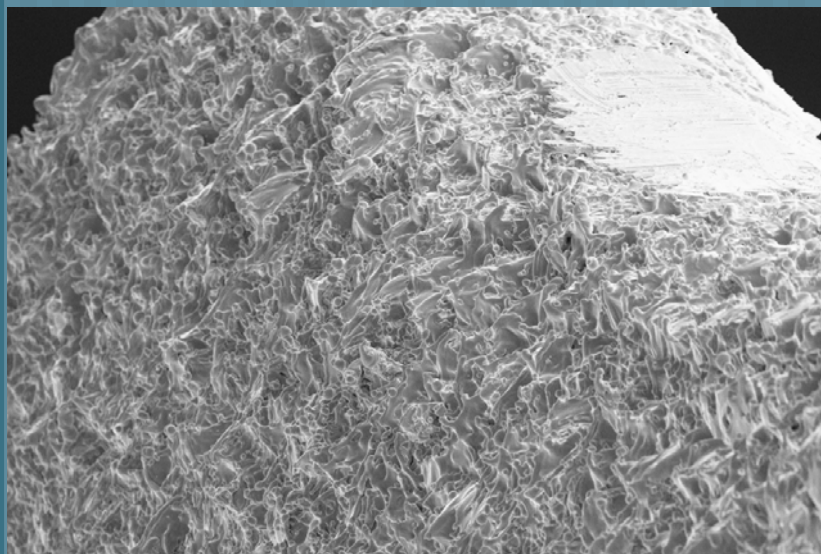
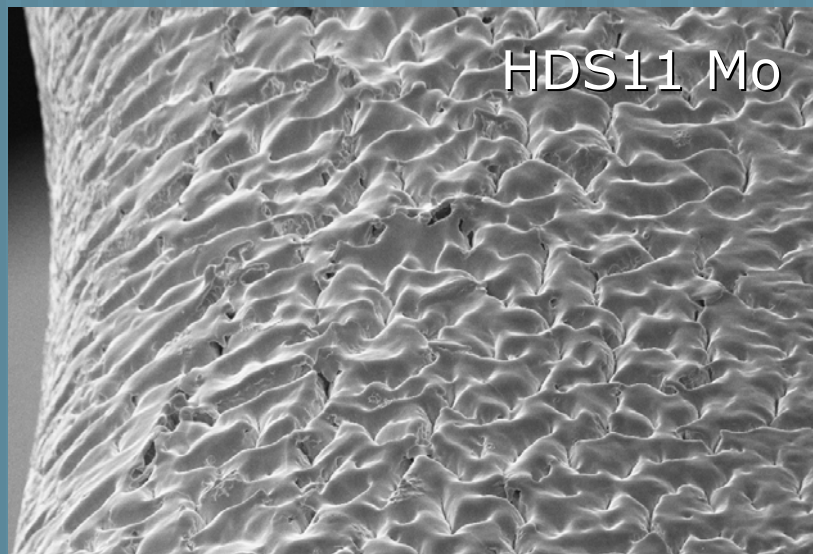
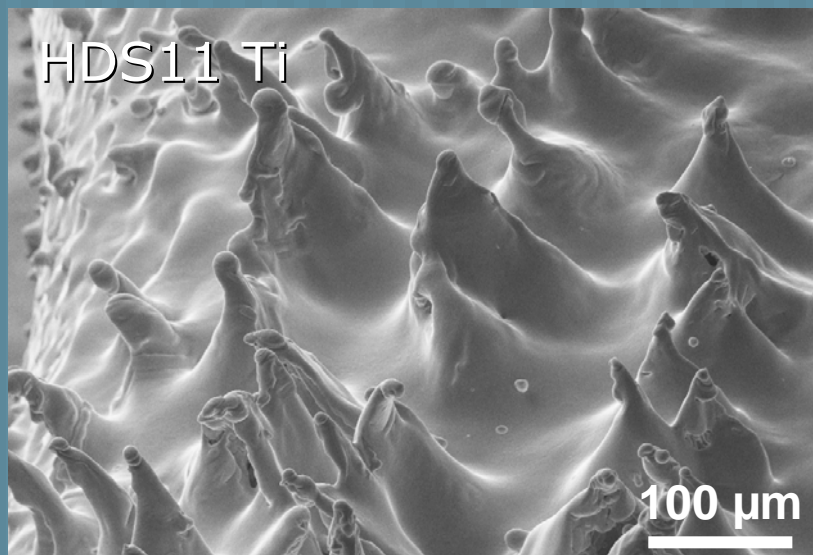
Growth of structures by **pulling of liquid** seems to happen in worst regions of **HDS60 Cu** and **HDS11 Ti** but is not evident in HDS11 Mo.

Intense damage features are most **oriented an high** in **HDS11 Ti** but they are also **less widespread**.

Only **HDS11 Mo** presents **cracks** (lower ductility, higher  $\Delta T$  from solidification to room temperature?)

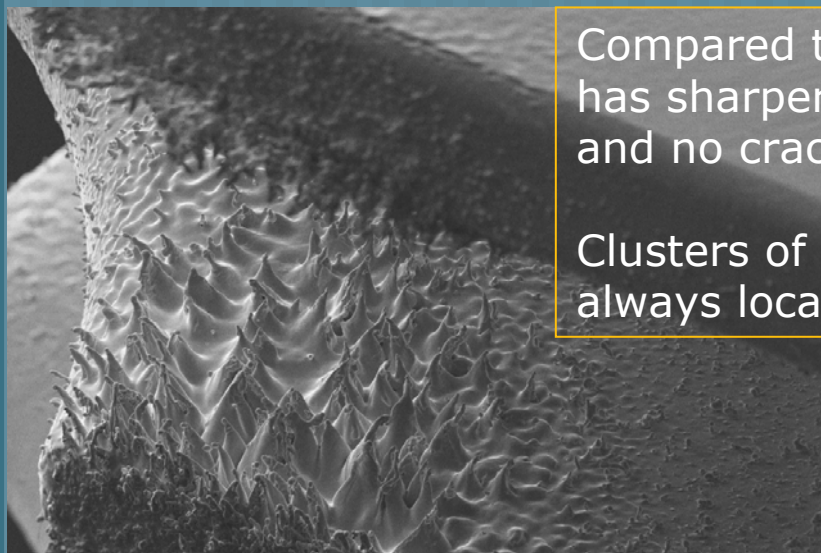
Compared to disc Mo structure, HDS Ti has sharper cones, less widespread and no cracks.

Clusters of craters are seldom, not always localized on top of the peaks.
