STATUS OF THE FATIGUE STUDIES OF THE CLIC ACCELERATING STRUCTURES

CLIC meeting 26.6.2003

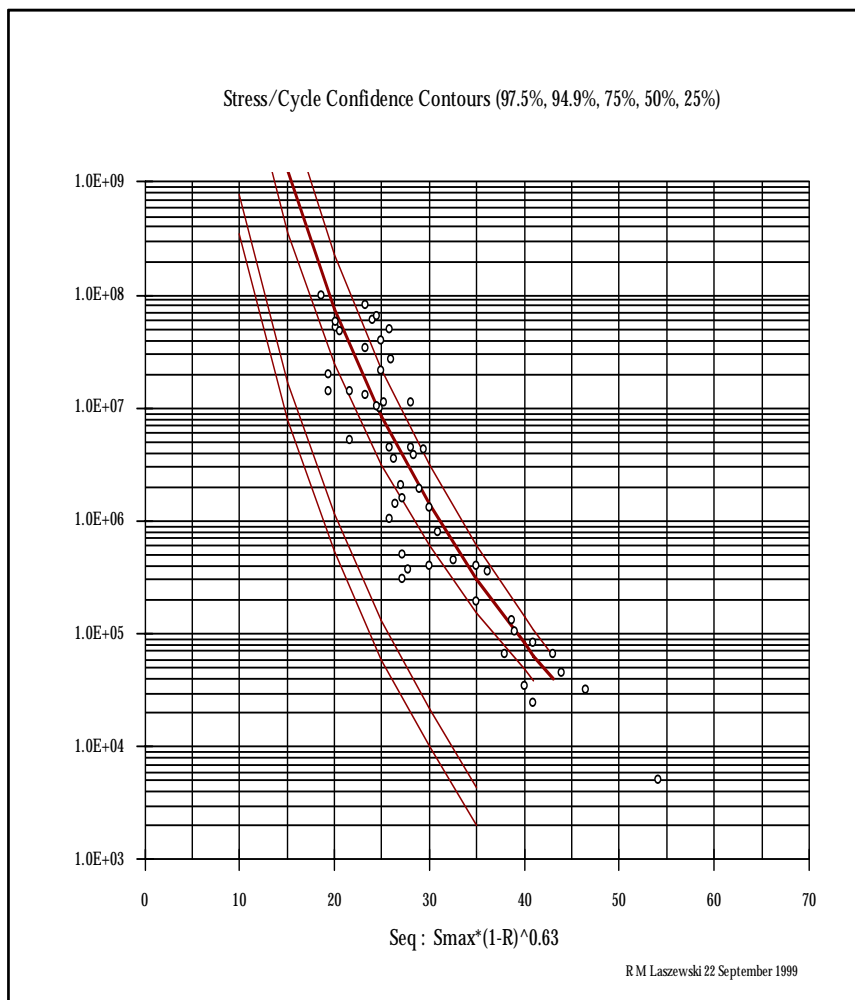
Confidence Curves on Equivalent Stress data plot

- This graph plots 55 MIL-SPEC data points corrected for R by the equation at bottom. The y axis is number of cycles to failure, the x axis is equivalent stress in ksi.
- From this graph we concluded that the equivalent stress for >97.5% confidence at 2×10^8 cycles was 10 ksi.

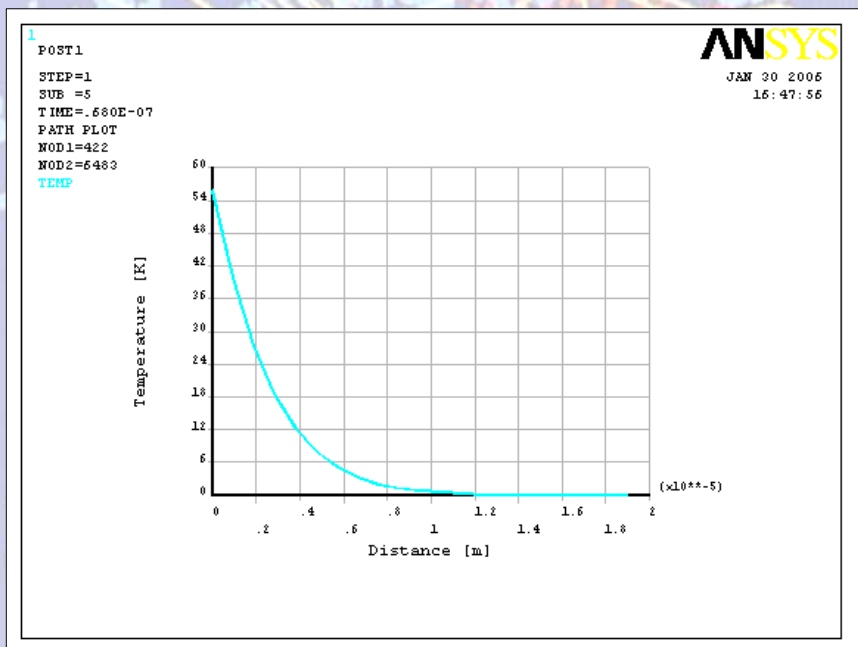
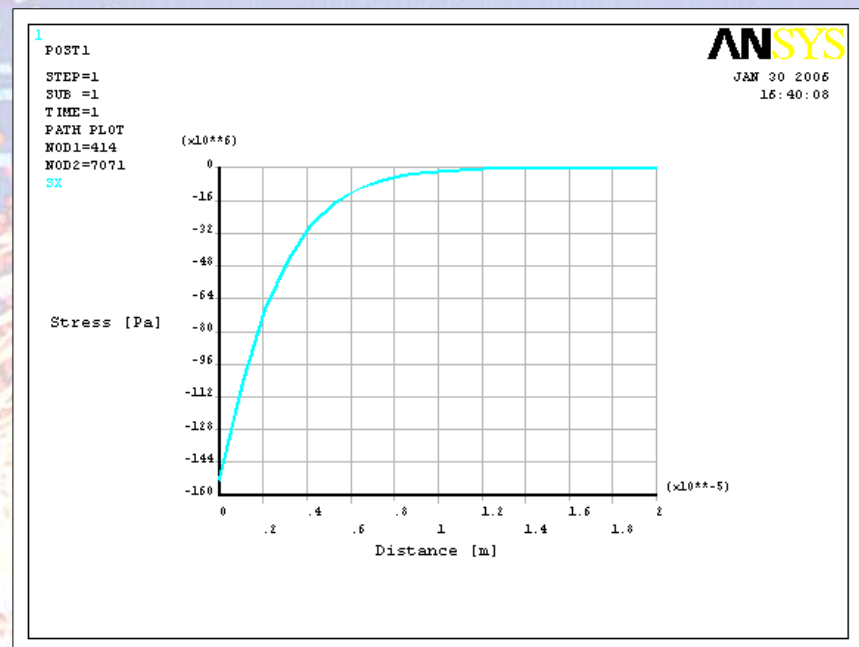
Max Temperature- and Stress profiles of 68 ns pulse

- Fully compressive cyclic stress condition
- Cyclic peak-to-peak stress 155 MPa
- Cyclic Stress Amplitude 77.5 MPa

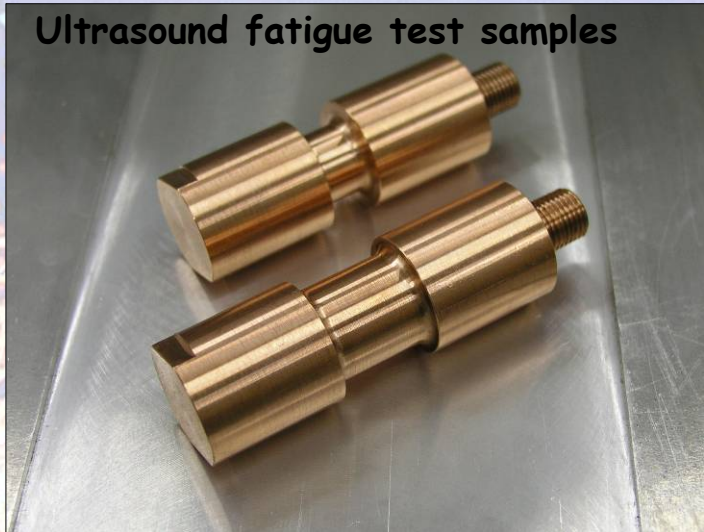
Ultrasound fatigue test samples

- Cyclic mechanical stressing of material at frequency of 24 kHz.
- High cycle fatigue data within a reasonable testing time. CLIC lifetime 7×10^{10} cycles in 30 days.
- Will be used to extend the laser fatigue data up to high cycle region.
- Tests for Cu-OFE, CuZr, CuCr1Zr & GlidCop Al-15 under way.

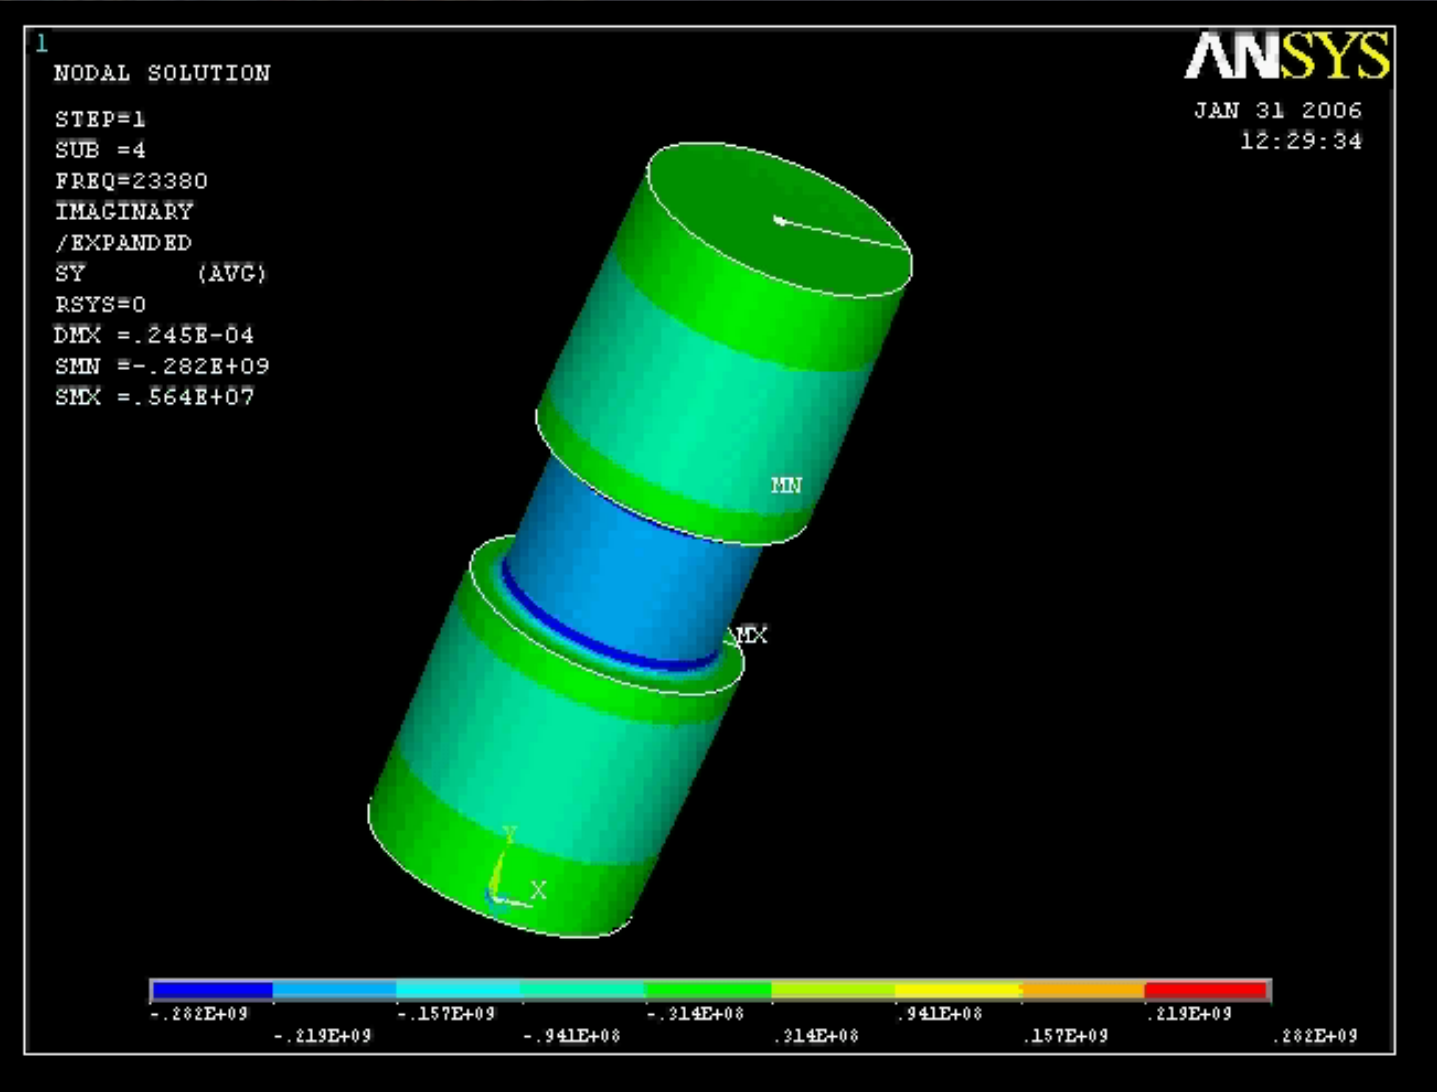
Simulated sonotrode vibration

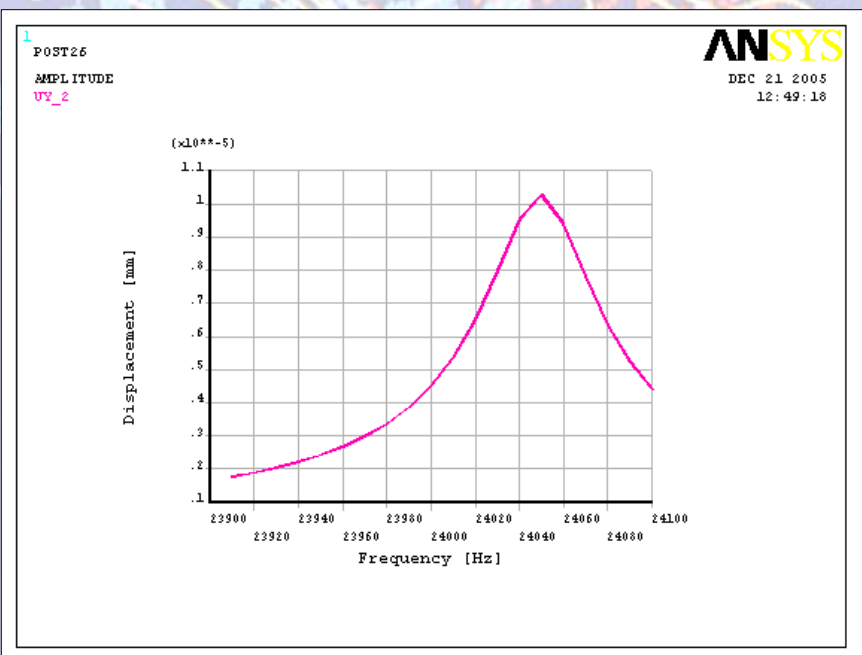
- The operating frequency of the Ultrasound unit is $24 \text{ kHz} \pm 1 \text{ kHz}$.
- A crack changes the resonant frequency of the sample.
- When the crack is about 2 mm deep, the sample is 1 kHz off the resonance and the device stops the "normal" operation.
- Material characterization at same time

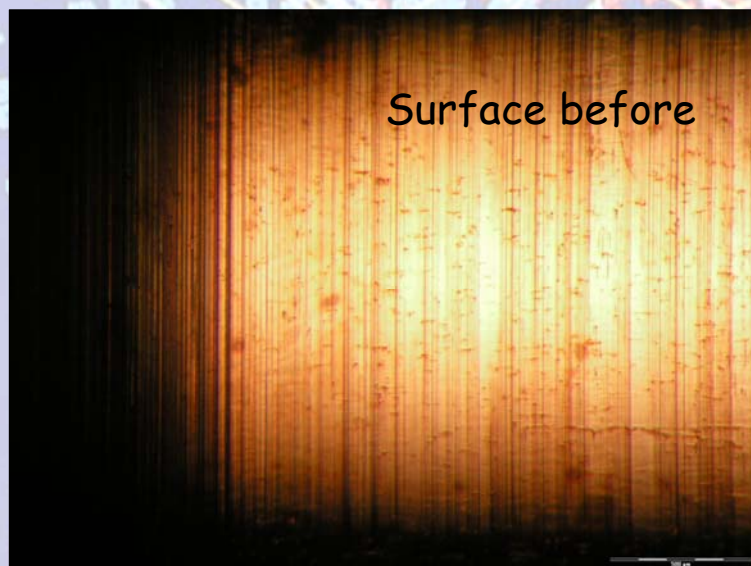
- The 40% Cold Worked CuZr sample survived the CLIC lifetime without a crack.
- Something happened on the surface already around 10^{10} cycles.
- If the surface roughness is increased, this could be dangerous for the RF induced fatigue.
