# SEM analysis of HDS accelerating structures from recent 30 GHz tests at CTF3.

- Old for memory and remarks.
- HDS60 Cu
- HDS60 Cu small
- HDS11 Mo
- HDS11 Ti
- Cross comparisons and comments

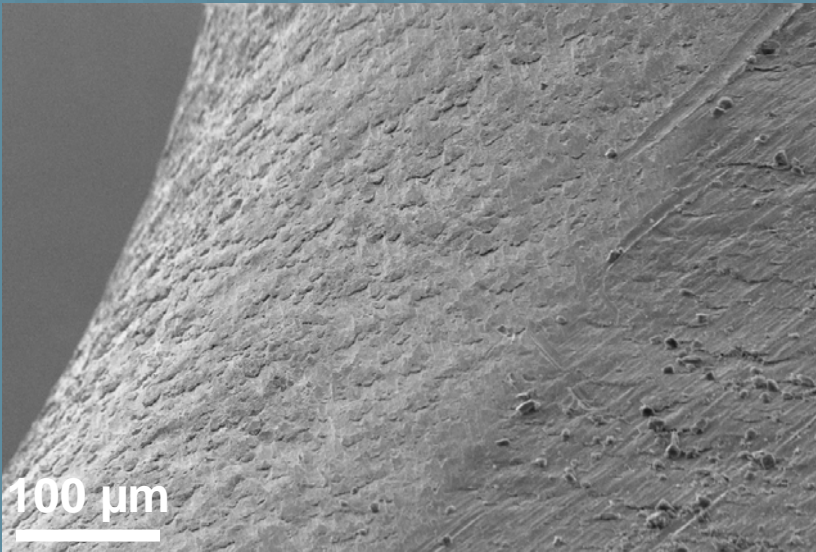
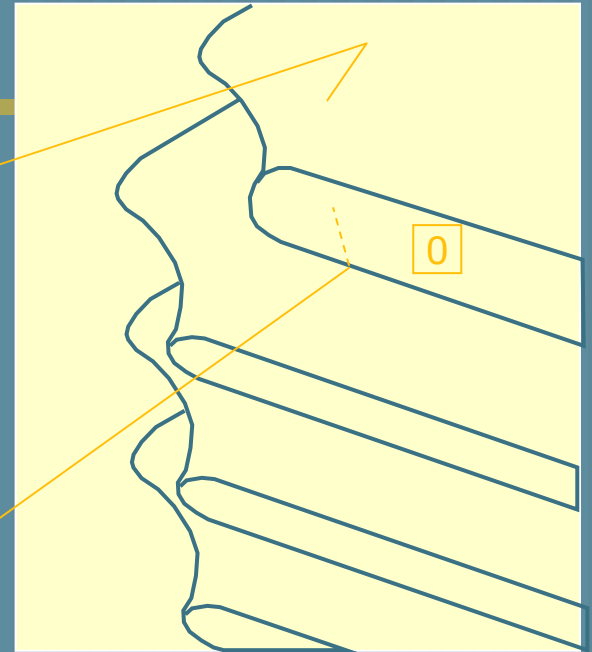
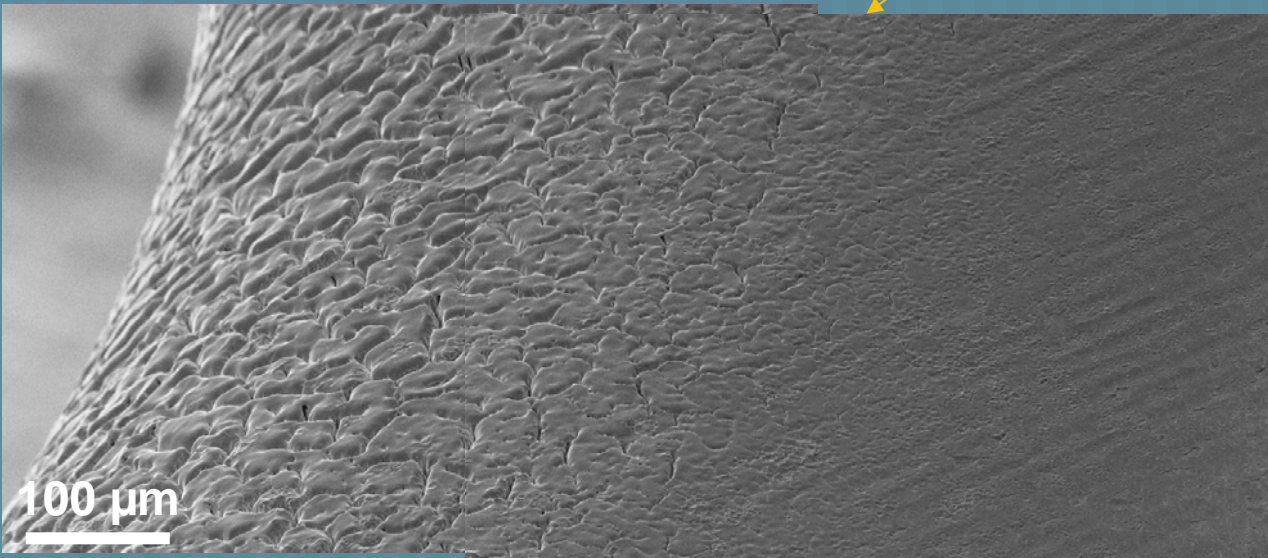
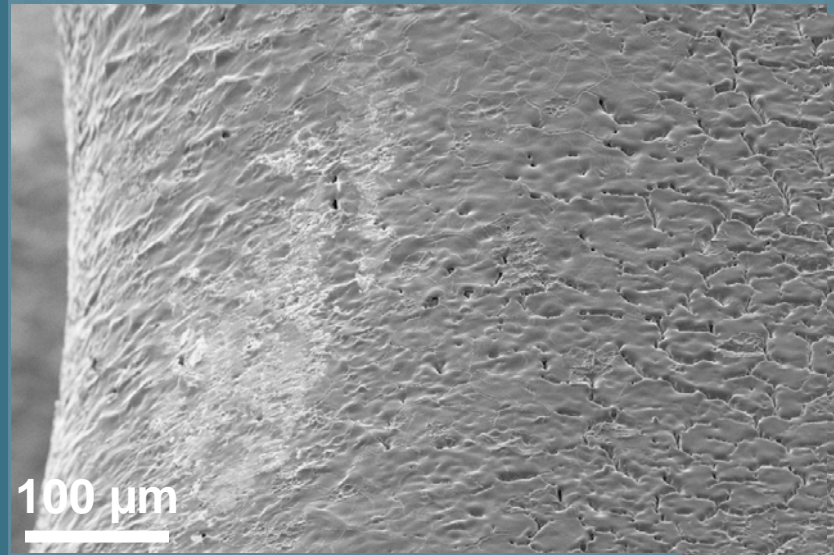
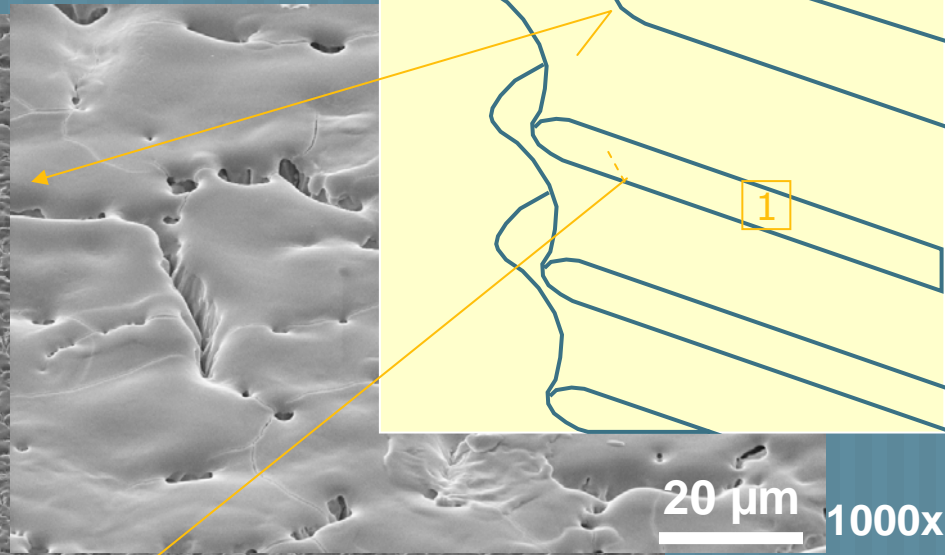
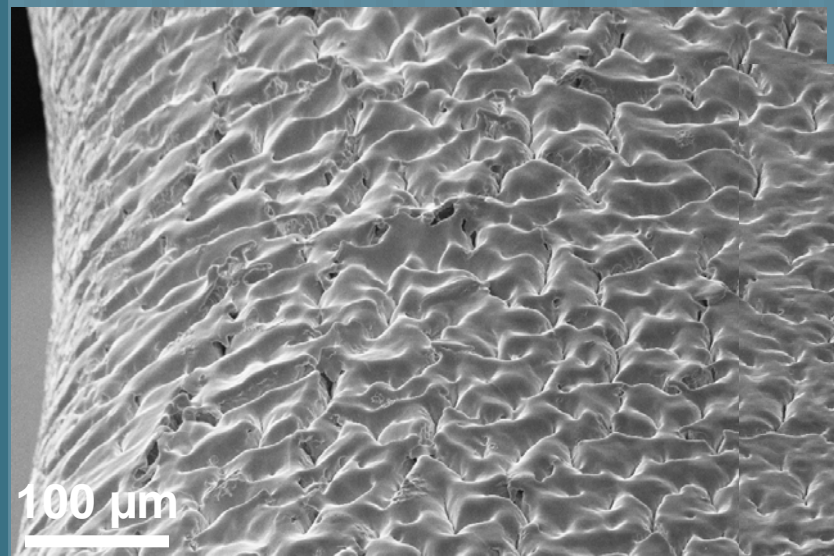
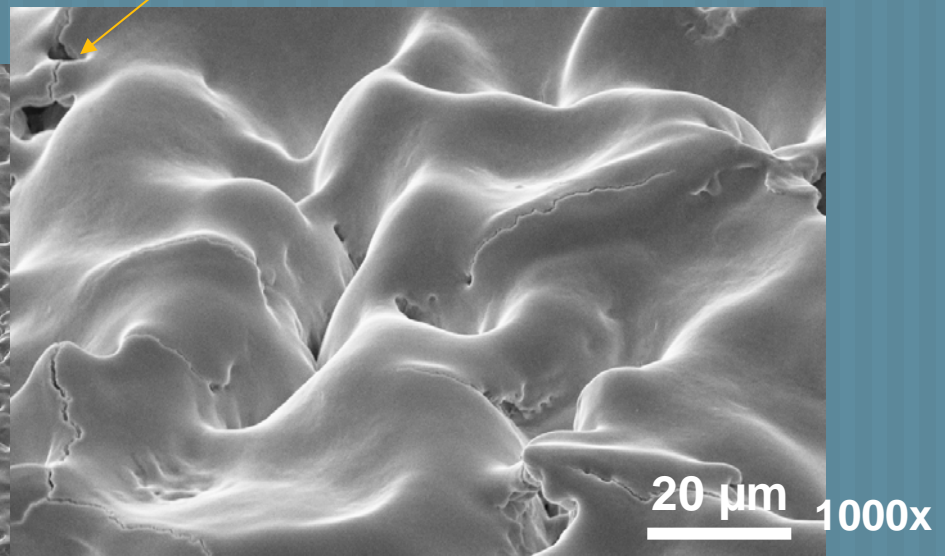
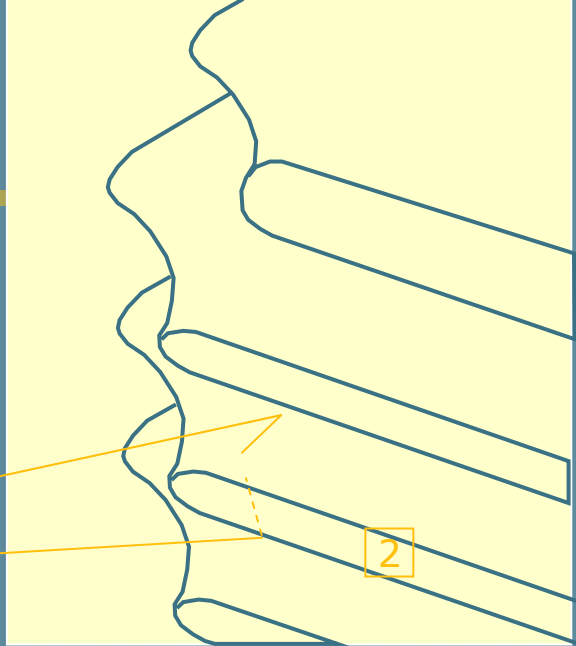
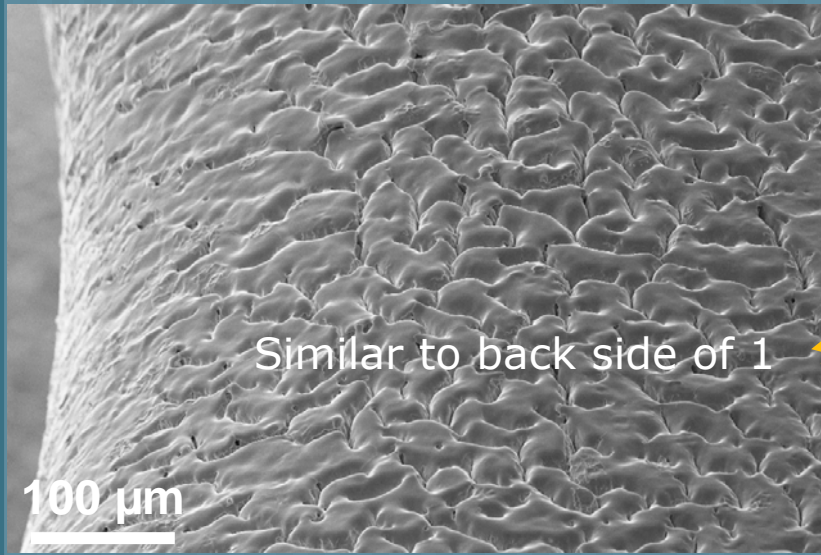
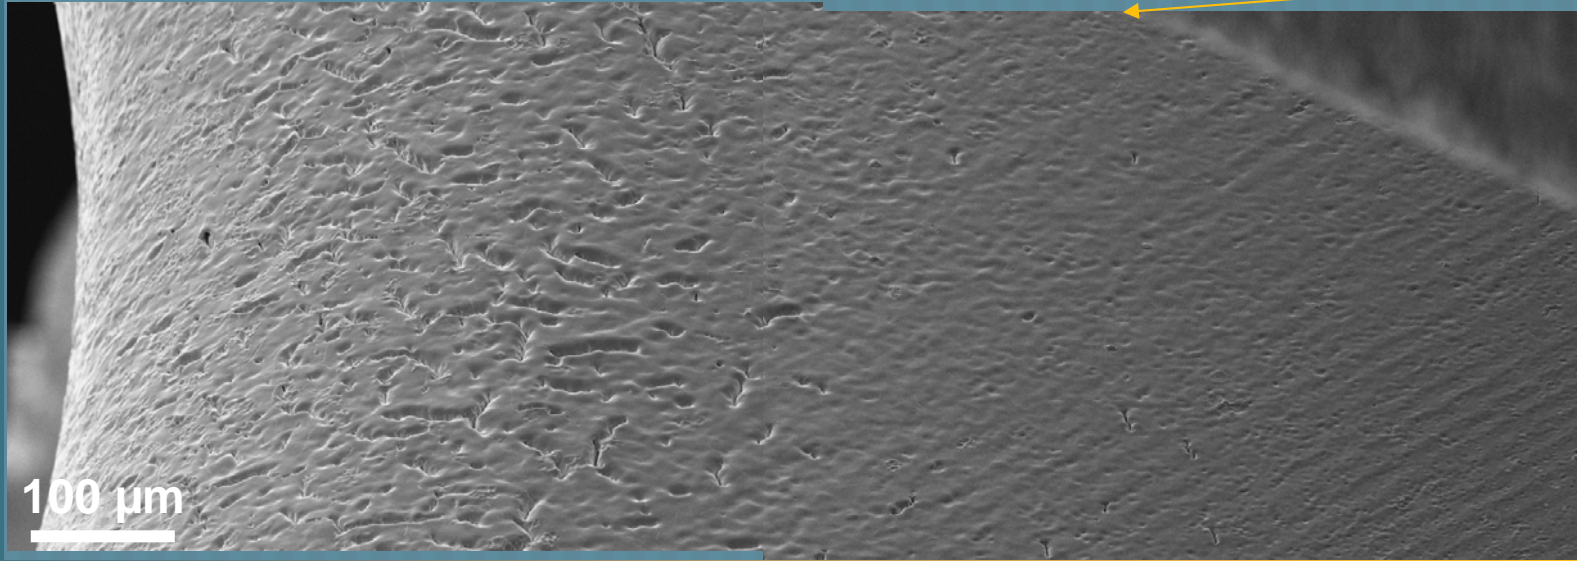
# HDS 11 Mo

Only **HDS11 Mo** presents **cracks** (lower ductility, higher  $\Delta T$  from solidification to room temperature?)

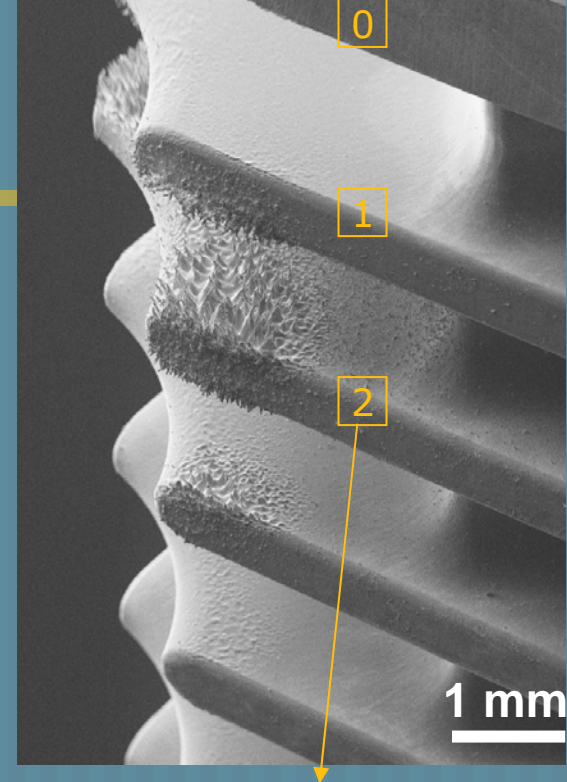
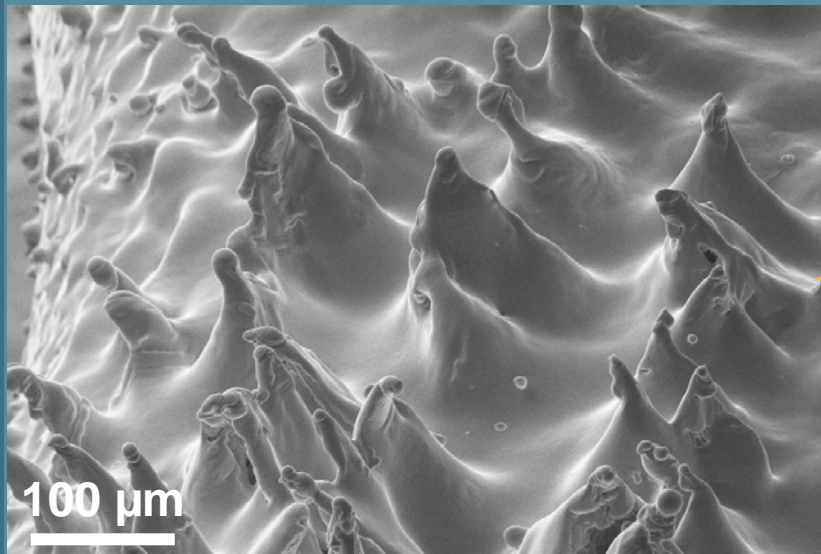
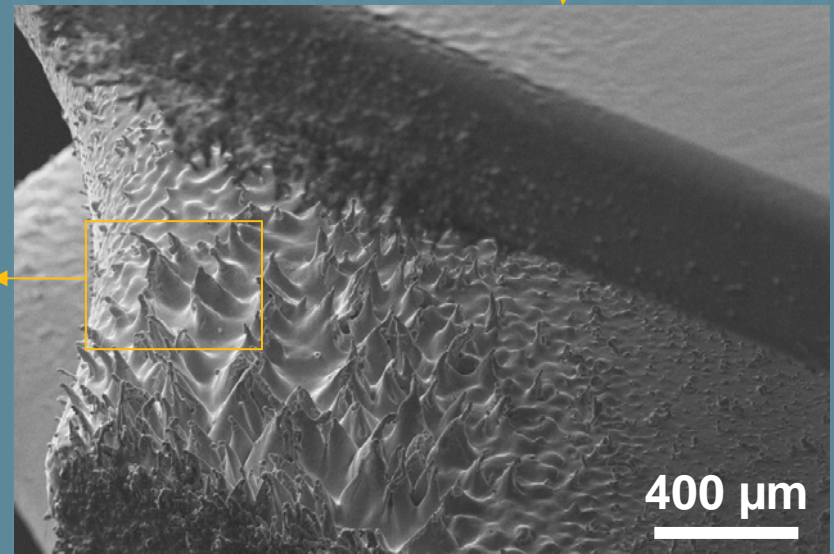
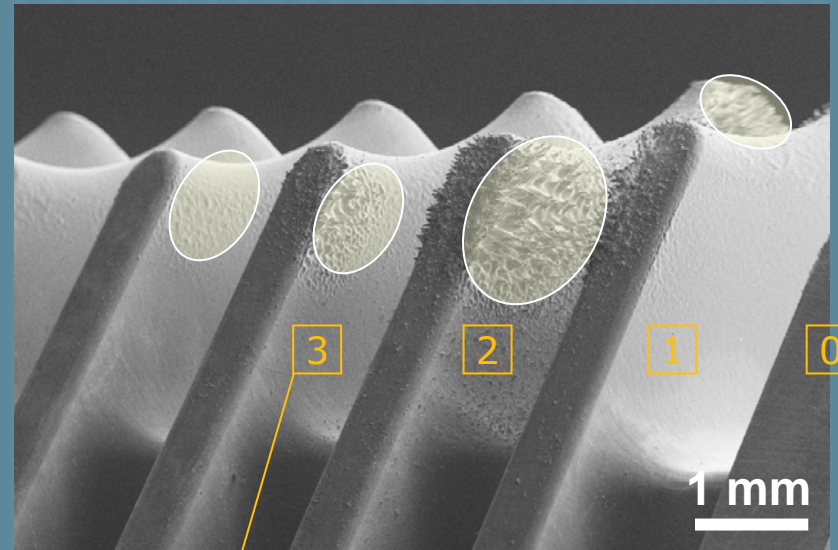
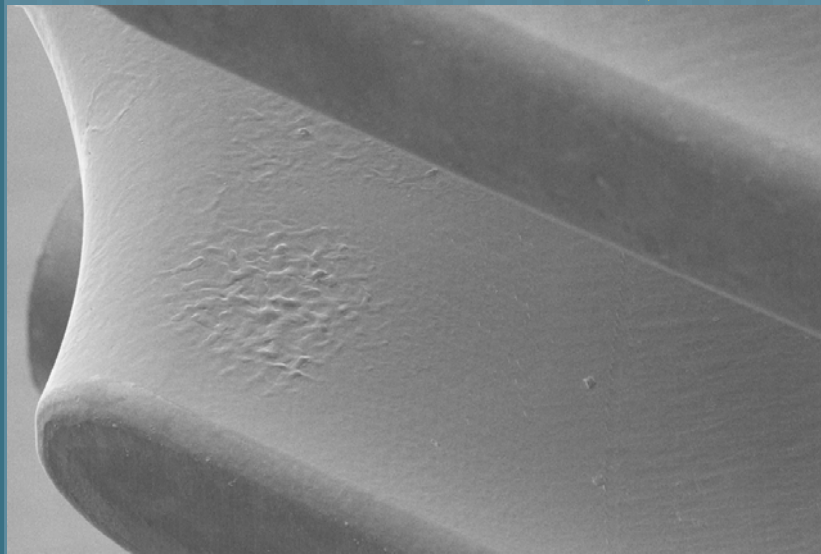
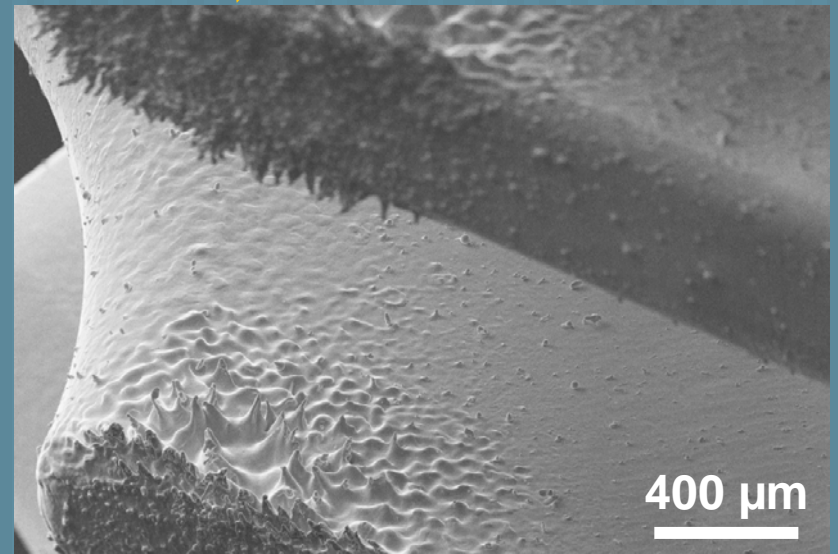
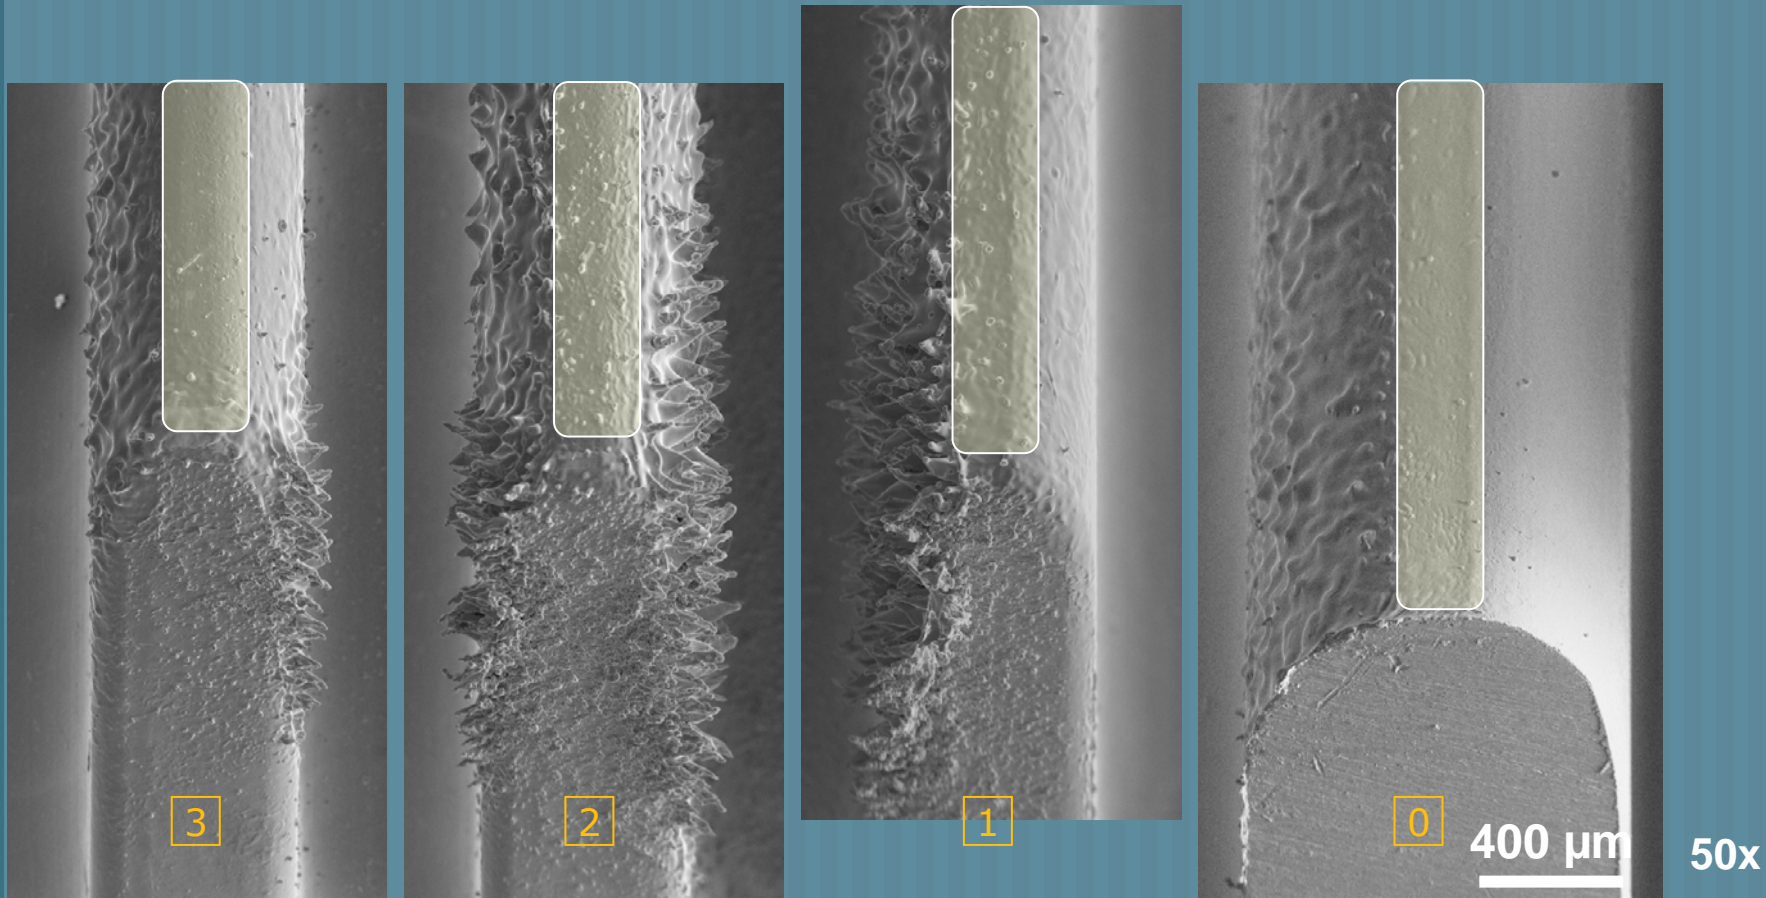
# HDS 11 Ti

Intense damage features are most **oriented an high** in **HDS11 Ti** but they are also **less widespread**.

Compared to disc Mo structure, HDS Ti has sharper cones, less widespread and no cracks.

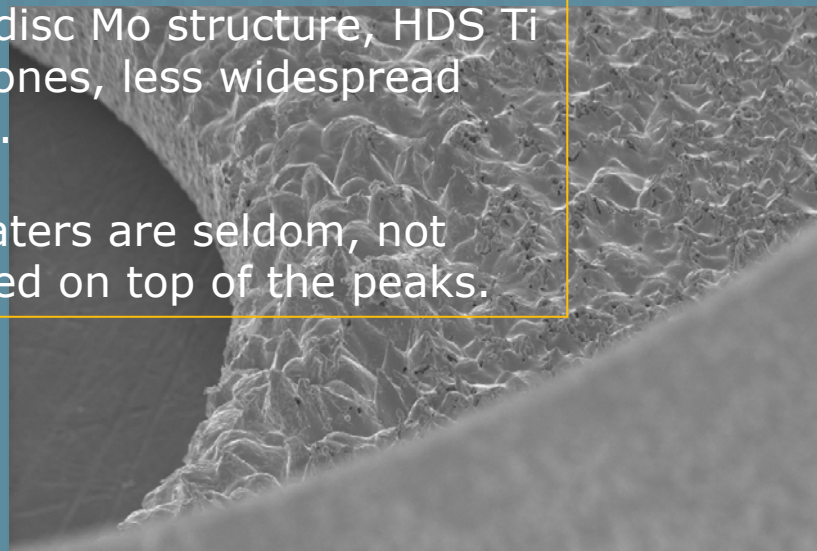
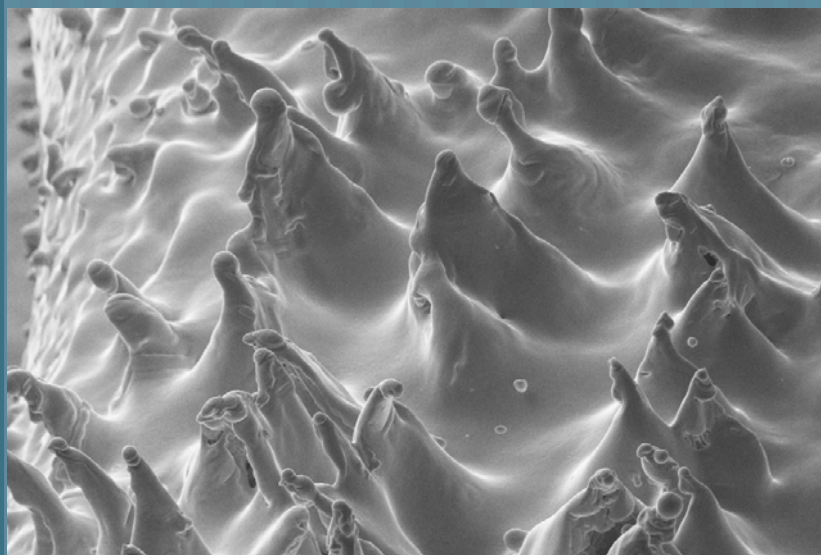
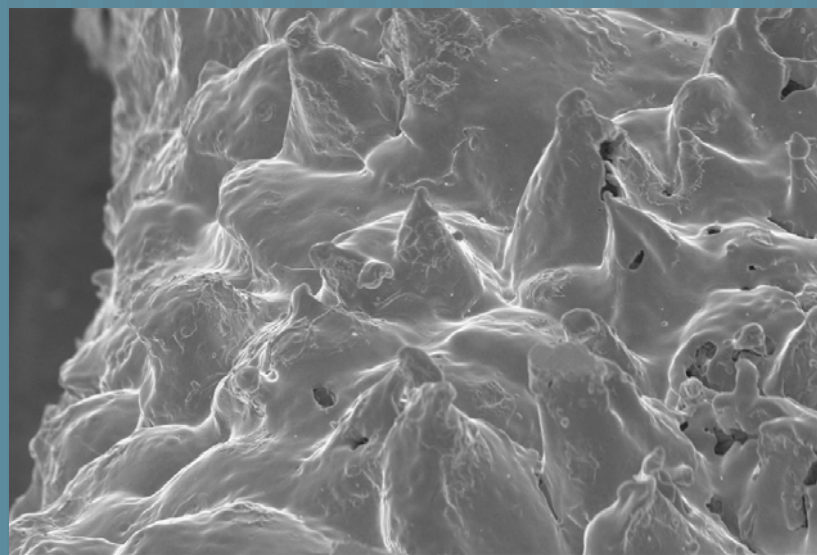
Clusters of craters are seldom, not always localized on top of the peaks.
